Pinson C2E Wind Turbine Generator
Failure Analysis and
Corrective Design Modification

M.J. Carr
V.K. Grotsky
J.H. Sexton

March 1980

Prepared by
Rockwell International Corporation
Energy Systems Group
Rocky Flats Plant
P.O. Box 464
Golden, Colorado 80401

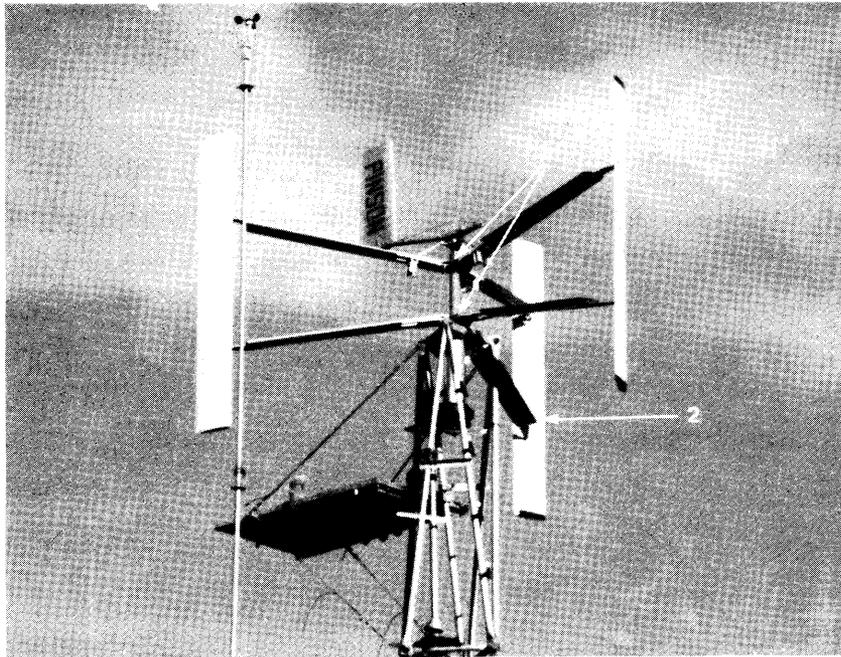
Figure 2

Overall view of the Pinson C2E Wind Turbine Generator
(1 = Rotor Shaft; 2 = Strut Attachment Point)

Cracks were observed in the skin material covering the blades, at five of the six places where the struts were attached (Figure 2). The cracks were located at the sharp corners of a square hole cut in the skin, through which two anchor points for the strut protruded. Figure 16 shows one such area with four cracks, one running out from each corner of the hole. The blades were generally of a riveted sheet construction. A manufacturer's label was found on an unpainted interior area indicating that the sheet was 6061-T6 aluminum. Therefore, it is assumed that all the sheet stock is 6061-T6.

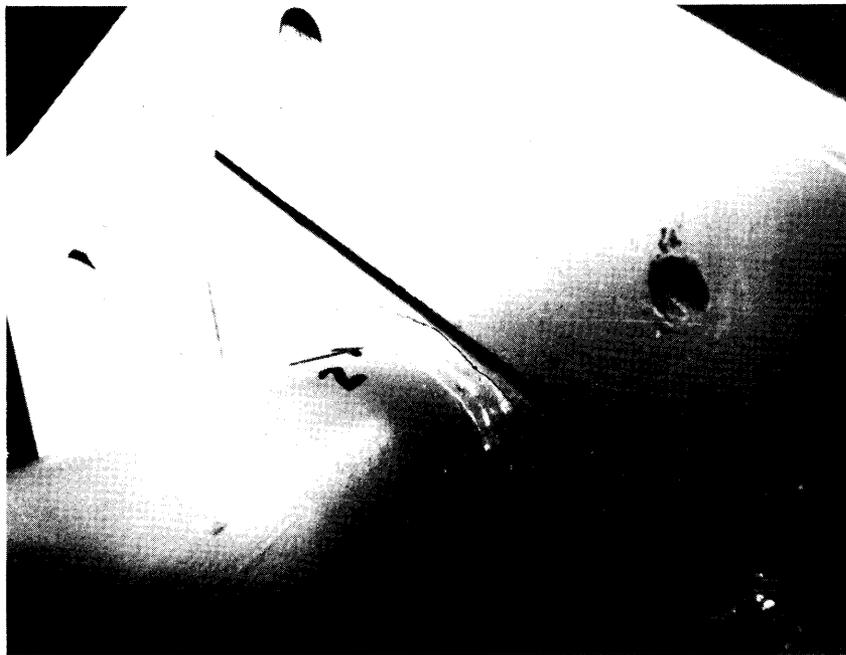
Two cracks were found on plates welded to the central rotor shaft of the Pinson C2E WTG. Figure 3 shows a close-up of one of the cracks, which both ran along the welds between a mild steel plate (1/4" thick) and a mild steel tube (1/4" wall thickness). Two such cracks were found. Both were located on the rotor plates in the area where the struts for the No. 2 blade were attached. The cracks appeared to be similar in nature, and only the crack in the upper plate was analyzed further.

Overall View of One of the Cracks in a Plate of the Rotor Shaft

1. The crack observed on the plate of the rotor shaft was a fatigue crack.
2. The loading under which this part failed was reversed bending caused by vertical deflections of the plate.

3. The cracks initiated in notches were caused by slag adhering to the surface of the weld, at the toe of the filler weld joining the plate to the rotor shaft (tube). Under normal loading, this is the area of highest stress concentration in the part.
4. The welds were generally of good quality with respect to structure and soundness. The steel used to make the plate contained 0.06% carbon; the steel used to make the tube contained 0.19% carbon. Both steels had normal hot-worked structures and are relatively free from inclusions.
5. Redesign of the failed part, with emphasis on improving the fatigue life of the unit, should be considered if this unit is to be rebuilt.

<u>Part</u>	<u>Original Specification</u>	<u>Corrective Modification</u>
Hub Plate	6.5mm (1/4")	25.5mm (1")
Blade Cut-Outs	Square Corners	Rounded Corners
Tower	Rohn SSV 6NW & 7NW with octahedron extension 16.8 m (55 ft) in height	Octahedron tower sections 2, 3, 4 and 5 with an oc- tahedron extension; 12.9 m (42.5 ft) in height

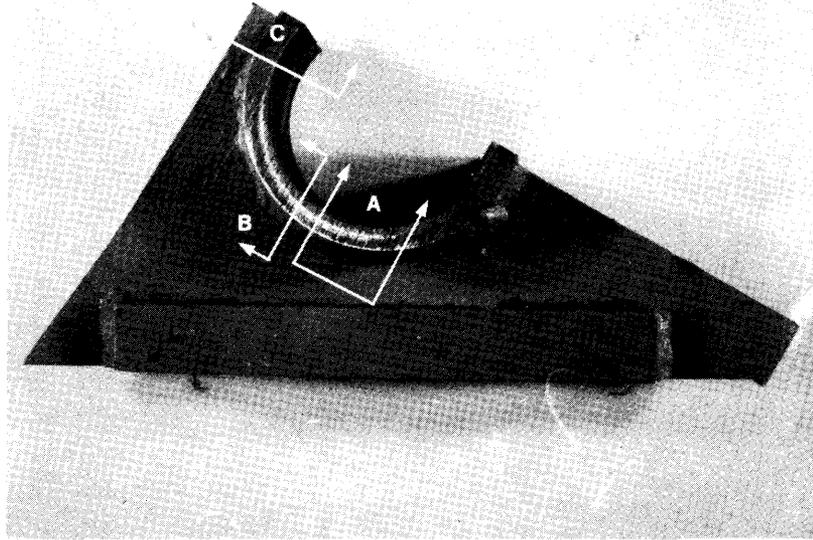
The section of the plate containing the crack was "bandsawed" out of the rotor shaft (Figure 4 and 5). The crack was located along the edges of the two fillet welds joining the plate to the tube. It appeared that the crack extended through the plate and was similar in extent on both sides of the plate. A section from the center of the crack (A in Figure 4) was carefully sawed free (Figures 6 and 7), at which time it fell into two pieces because the crack went completely through the plate. The fracture surface was slightly rusty but clearly showed beachmarks typical of fatigue. The presence of a linear feature running along the centerline of the fracture, coupled with the

Figure 4
Section of the Cracked Rotor Shaft Plate Showing the
Location of the Subsequent Samples

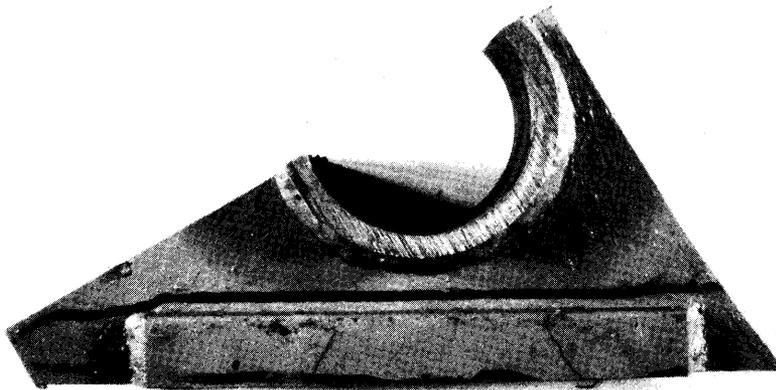
Figure 5
Reverse View of Figure 4 Showing Similar Extent of Cracking

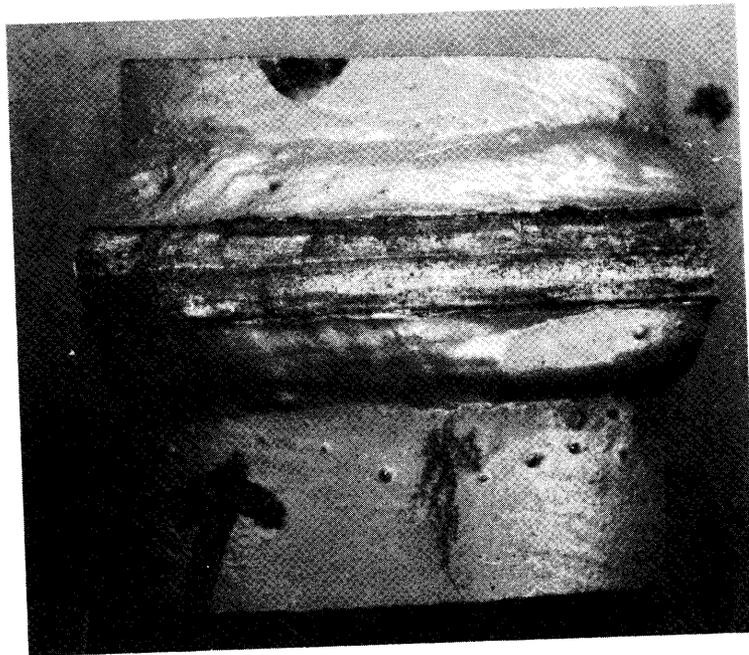
Figure 6

(A) Mating Half of the Fracture
Surface of Section A in Figure 4

orientation of the beachmarks, indicate that this plate was loaded in reversed bending due to vertical cantilever deflections of this plate. This was an observed vibration mode in which the blades attached to the rotor plate by struts displace vertically, parallel to the central shaft, while in operation.

The stepped shape of the edges of the fracture surface indicate that the fatigue crack had many initiation sites, which subsequently grew together into two large cracks which met at the center line.

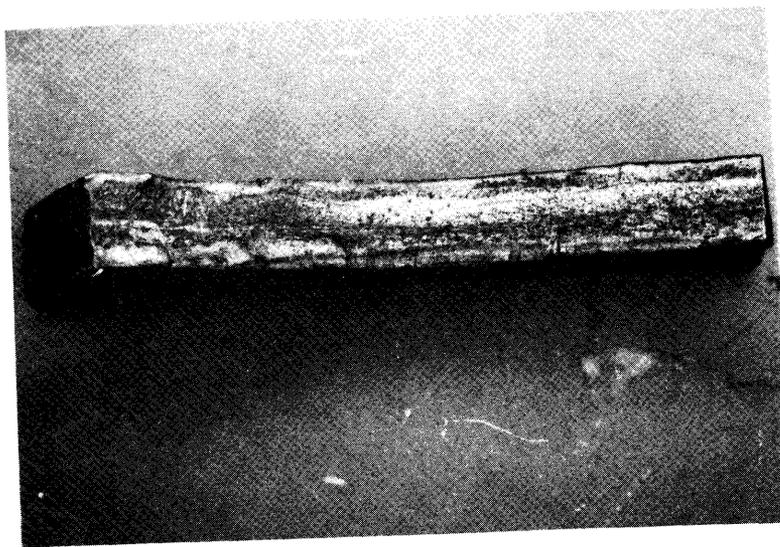
(B) Mating Half of the Fracture
Surface of Section A in Figure 4

The piece shown in Figure 7 was examined in the Scanning Electron Microscope (SEM). Figure 8 is an overall view of an area of the fracture surface showing three areas selected for closer viewing. Figures 9 and 10 show an area in the beachmarks near the edge of the piece. Fatigue striations in this area have a spacing of about 0.5μ /striation. Figure 11 shows an area near the middle where the spacing of striations is about 0.3μ /striation. Figure 12 shows striations found near the opposite edge. Again the spacing of striations was similar to the other locations, about 0.4μ /striation. These measurements represent upper limits on the spacing of striations on this surface; finer striations may exist below the resolution limit of the SEM.

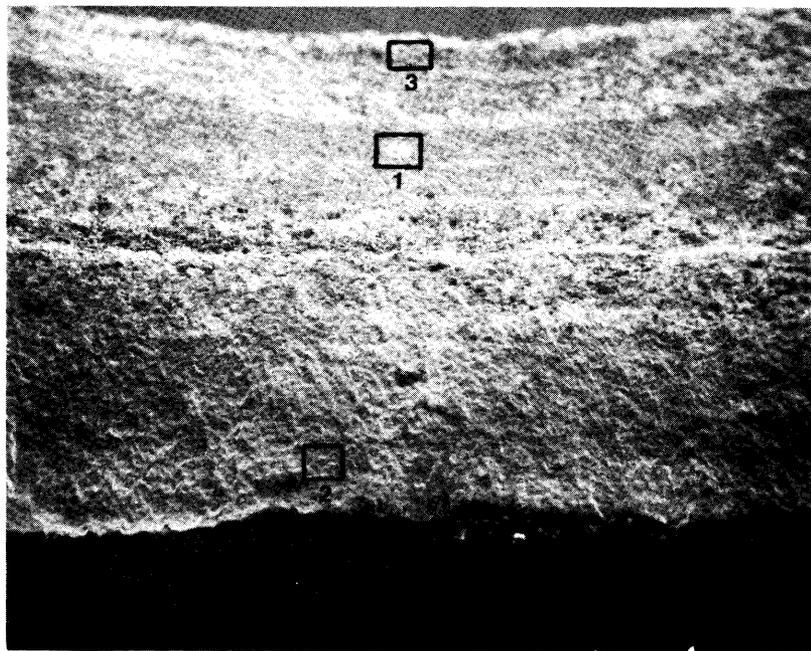
Figure 8
SEM Micrograph of the Fracture Surface
Shown in Figure 7. Subsequent Micrographs
were taken near the Numbered Areas. (20X)

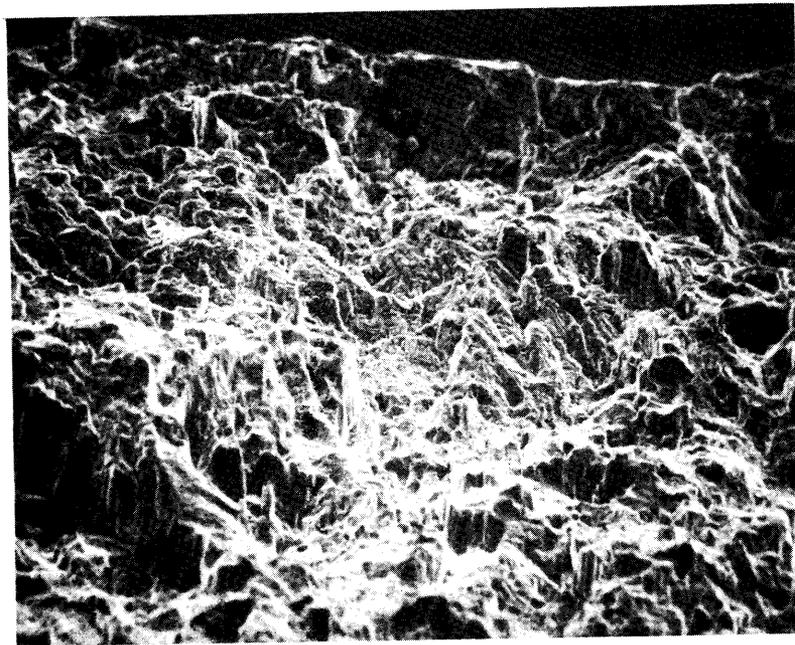
Figure 9
Area 3 in Figure 8 (400X)

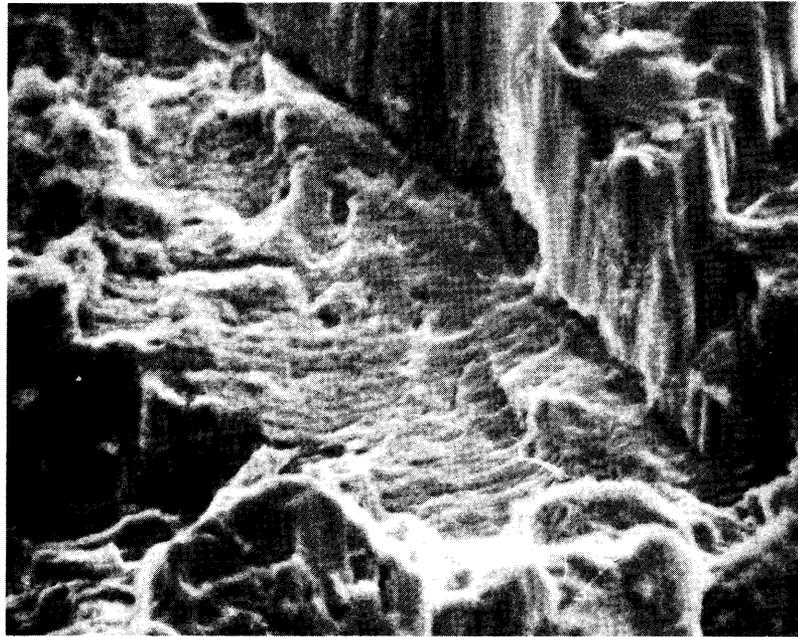
Figure 11
Fatigue Striations near No. 1 in Figure 8 (4500X)

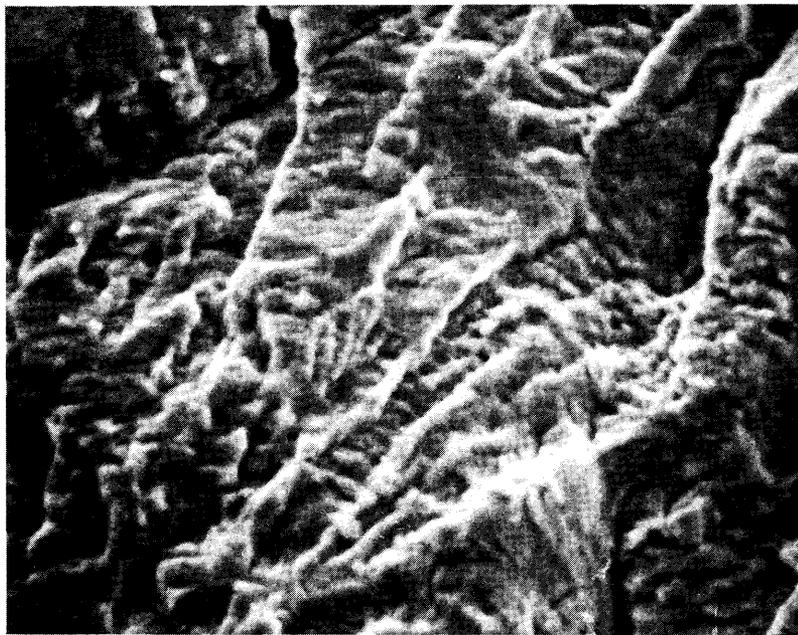
Figure 12
Fatigue Striations near No. 2 in Figure 8 (5000X)

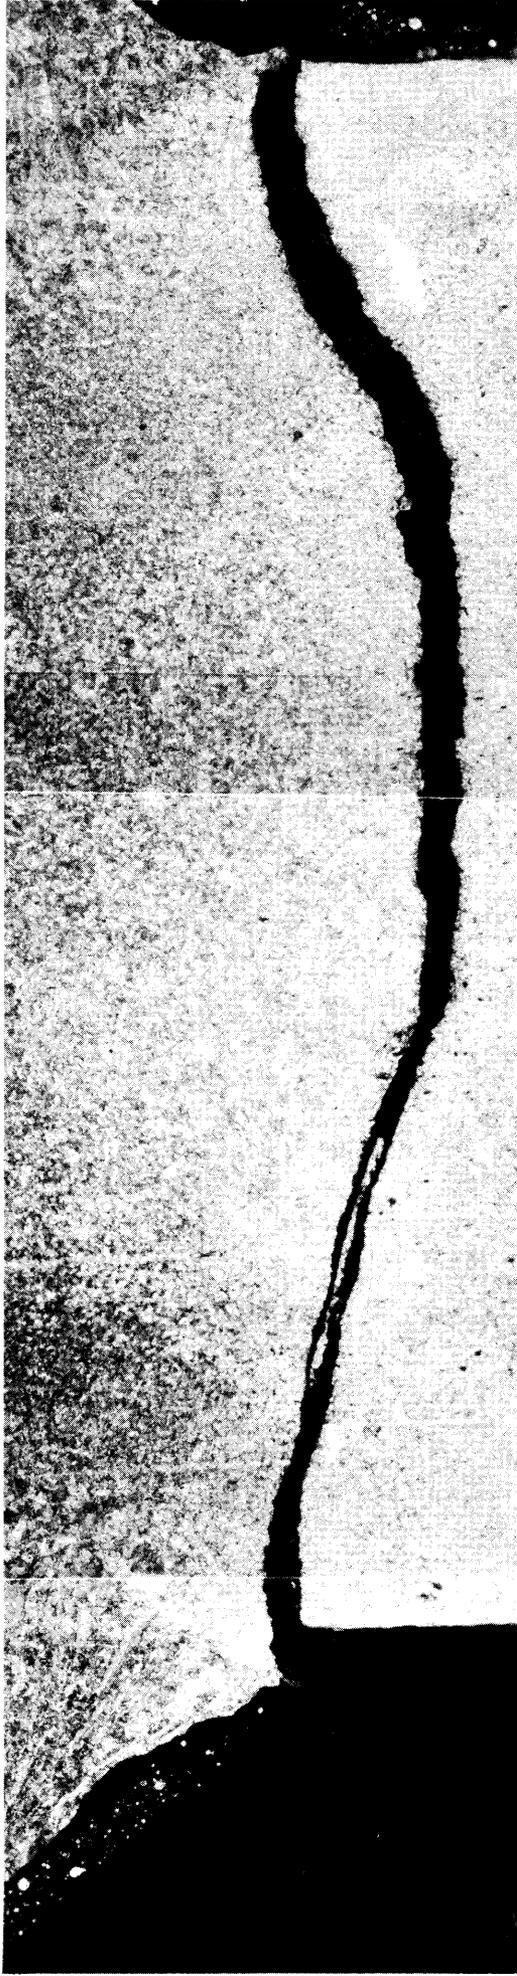
A cross section of the cracked area (B in Figure 4) was mounted, polished and etched with 2% nital. The crack was seen to start at the toes of the two fillet welds and to run completely through the plate (Figure 13).

Figure 13
Optical Micrograph showing the Crack Traversing
Section B in Figure 4 (40 X)

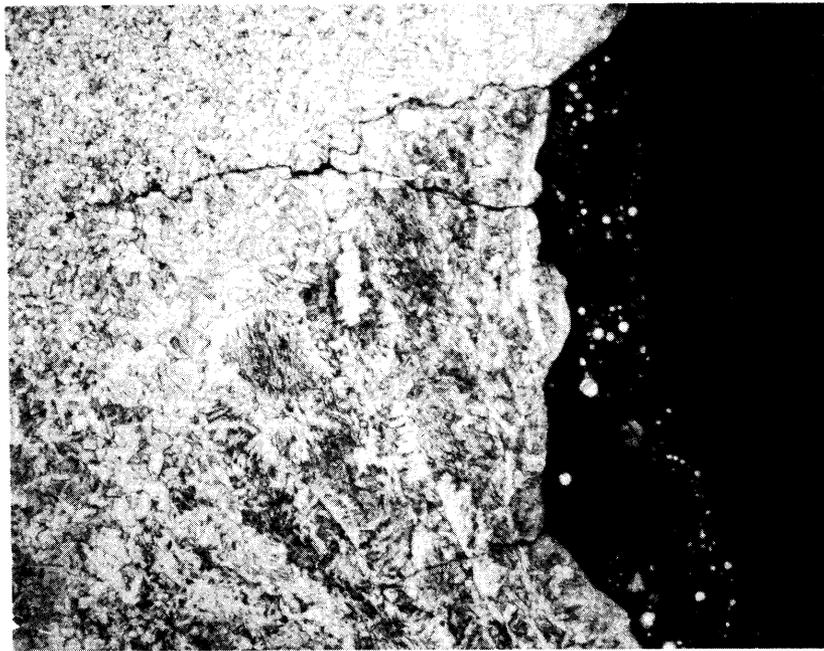
A second cross section from an uncracked area (C in Figure 4) was similarly mounted, polished and etched. Cracks were again found in the plate near the toes of the filler welds (Figures 14 and 15). These cracks emanated from notches due to slag (Figure 15) and ran only partially through the plate.

Figure 14
Fatigue Cracks Found in Area C of
Figure 4, an "Uncracked" Area. (80 X)

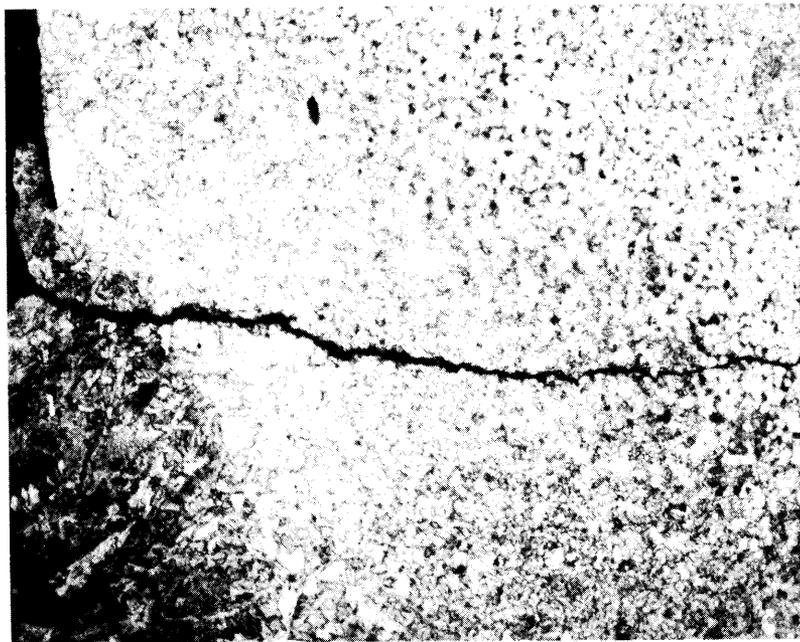
Figure 15
Fatigue Cracks Found in Area C of
Figure 4, an "Uncracked" Area. (80 X)

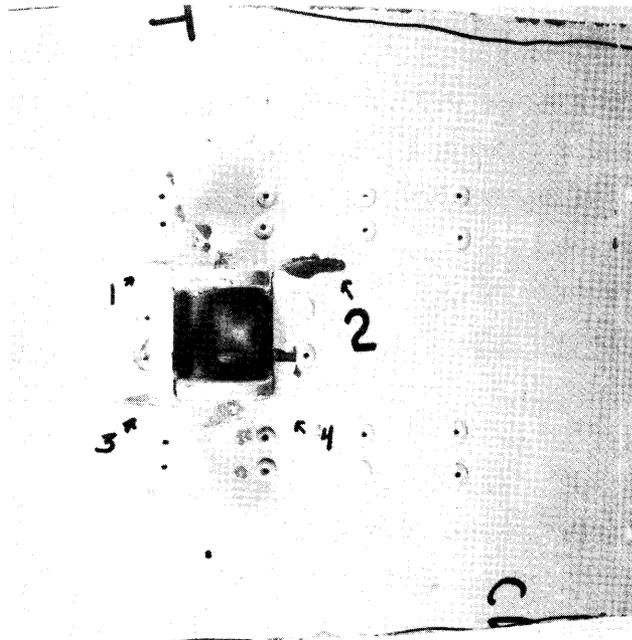
The cracks in the skin of the blades were fatigue cracks which propagated out from the sharp corners of square holes cut in the skin to past the attachment points for the struts. The sharpness of the corners is probably the primary cause of these cracks, coupled with the overall design of the joint which causes the skin to be pushed outward at the hole. Redesign of the joint with consideration for its service in a fatigue environment (i.e., rounded corners, no load on skin) should be considered when this piece is replaced.

1. The cracks in the skin of the blades were fatigue cracks.
2. The cracks were due to the design of a joint which caused high stresses to be applied at the sharp corners of a square hole.

Figure 16
Overall View of Cracks in the Skin of a
Blade. The Numbers Indicate the Cracks.

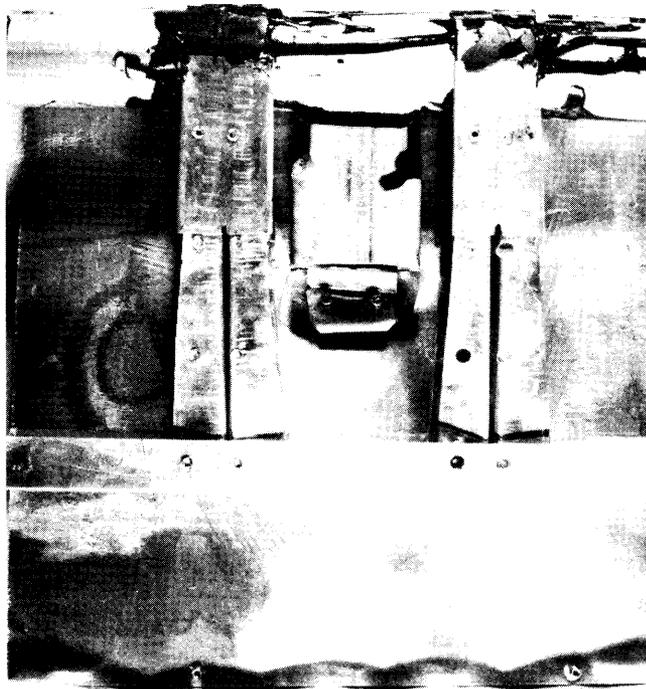
The skin sheet was removed from the backside of the blade (Figure 17). This showed that the main loading on the blade was borne by a tubular strut, to which was welded a box section tube. The strut attachment points were welded to this box section tube. A square bottomed "u-shaped" piece was positioned in the square hole and riveted to the skin in order to roughly seal the remaining open area around the hole.

The arrangement of these parts was such that when tension was applied at the strut attachment points, the skin was bowed outward. The cracks which were observed appeared to have initiated at the sharp corners of the square hole and run outward in response to this loading.

Figure 17
Reverse View of Figure 16 with the Skin
Removed, Showing Interior Construction

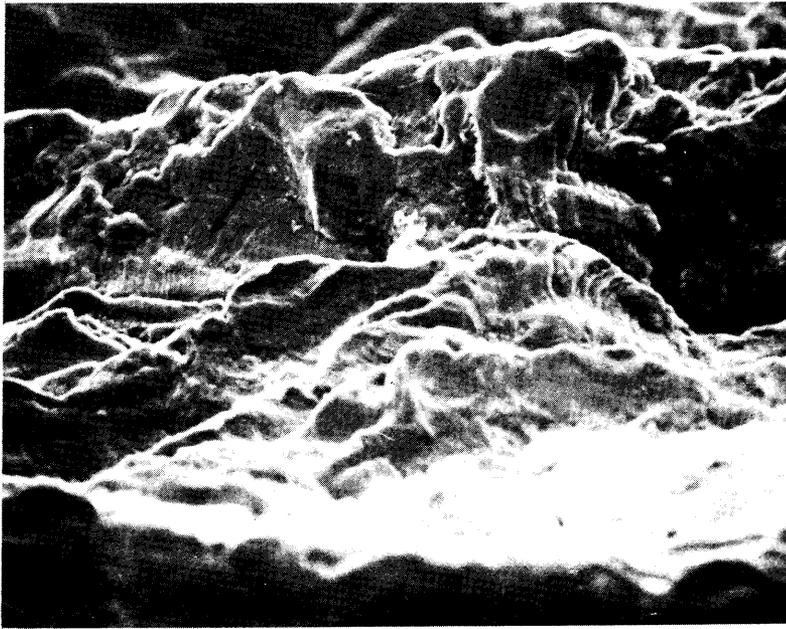
Figure 18

The crack labeled No. 2 in Figure 16 was carefully excised and then pulled open so that the fracture surface could be observed. Much of the fracture surface showed signs of rubbing, particularly near the origin, and so was useless for fractography. However, a few areas were found which clearly showed fatigue striations (Figure 18) with spacings of about 0.6μ /striation. Little or no reduction in area was observed at the crack, which is also a sign of a fatigue since this material is ductile and normally shows some necking prior to failure.

SEM Micrograph of Fracture Surface of Crack No. 2 in Figure 16 Showing Fatigue Striations Found 3 mm from the Origin. (1000 X)

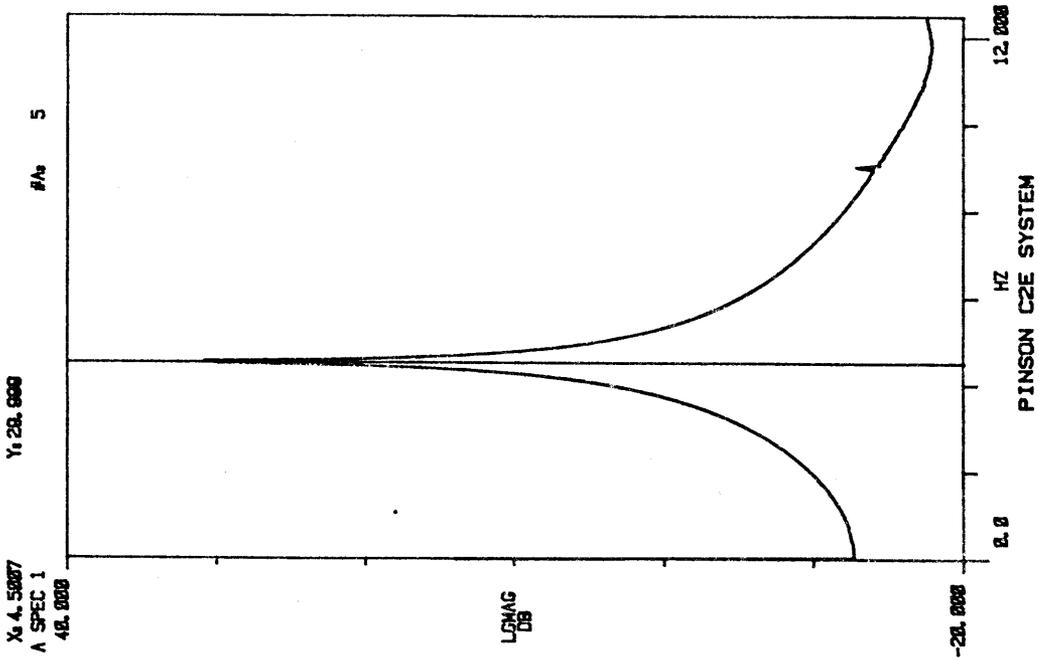
The natural frequency (first mode bending) of System 1 was determined to be 4.5 Hz (Figure 19). The time history of the response is presented in Figure 20. The natural frequency of System 2 was found to be 2.5 Hz as shown in the auto spectrum in Figure 21. Figure 22 depicts the time history of the response for System 2. A summary of vibration test results is presented in Table I.

Vibration test results indicate the WTG/tower interaction of System 1 was a partial cause of the failure due to passing through resonance at 90 rpm. The 90 rpm represents a higher energy input than does 50 rpm, due to the corresponding winds at the two rotor speeds. System (1), while in operation, was seen to go through "violent" vibrations at 90 rpm, while System (2) goes through a rather gentle "rocking" motion at 50 rpm. It must be noted, however, that if a 1P excitation was experienced for any reason (icing, rotor imbalance, etc.), System (2) would go through resonance at 150 rpm, which is close to the rated rpm of the C2E. The manufacturer has been notified of this situation. This possibility (a 1P Excitation) will be closely monitored.

Natural Frequency (first mode bending)
of the Pinson C2E System (1)

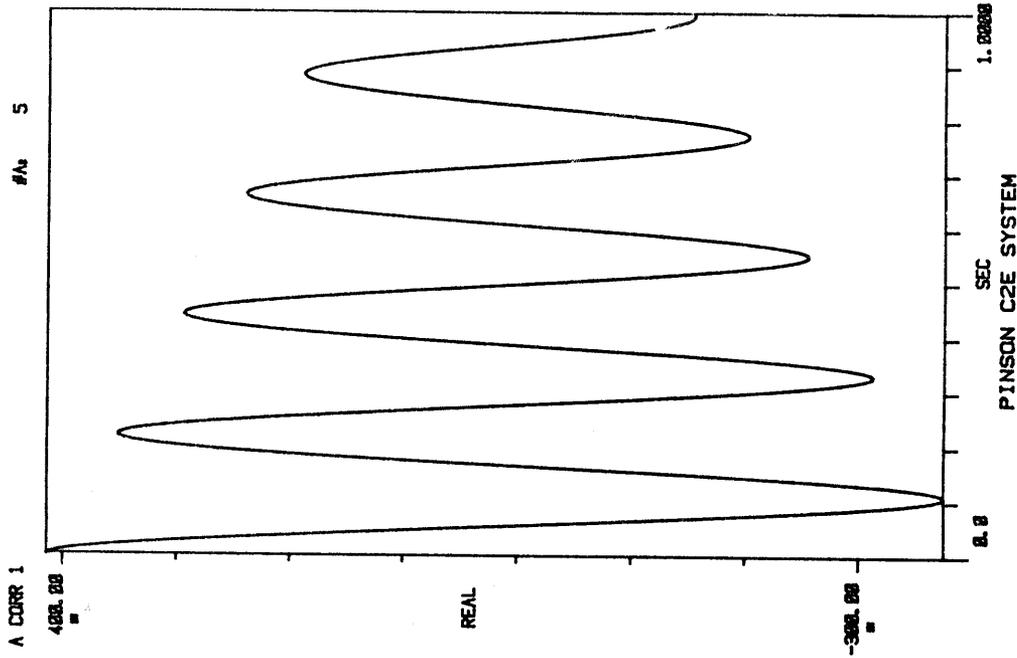
Time History of the System Response
for the Pinson C2E System (1)

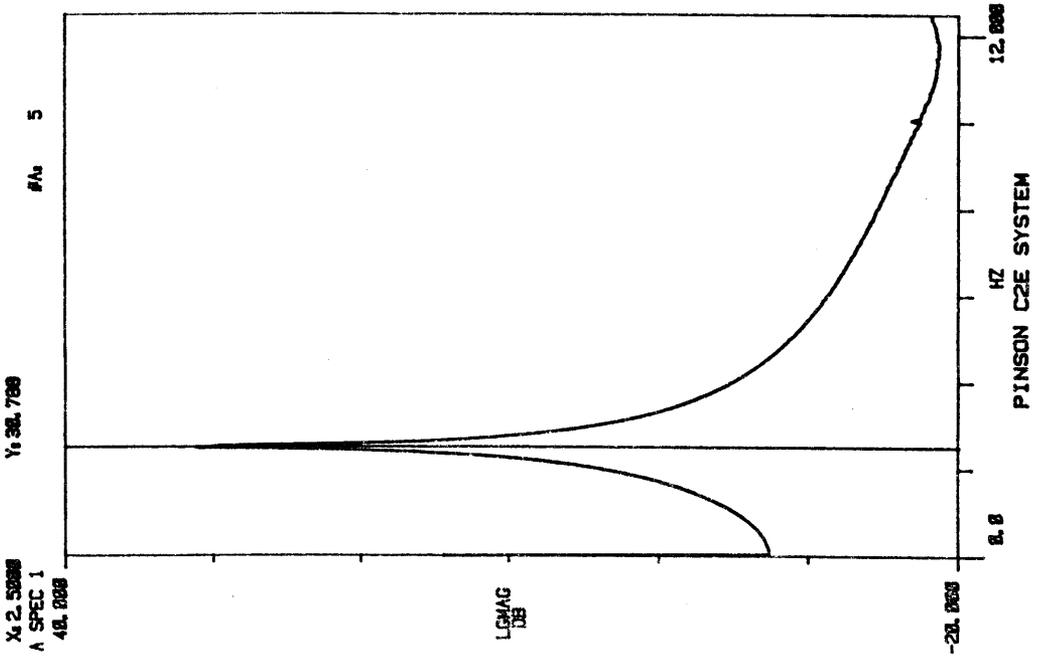
Natural Frequency (first mode bending)
of the Pinson C2E System (2)

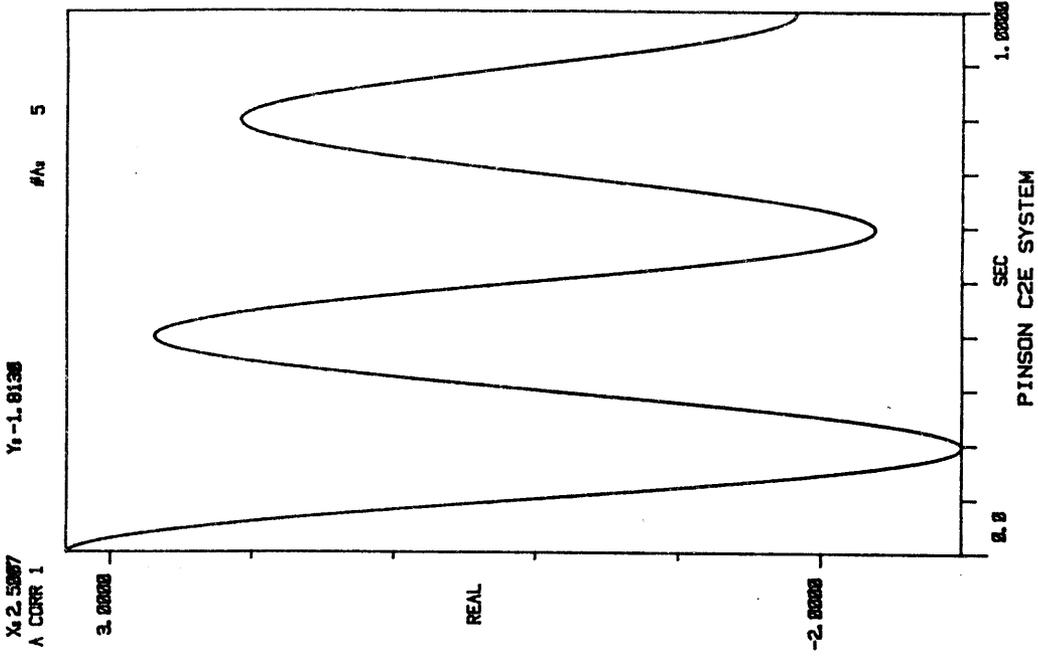
Time History of the System Response
for the Pinson C2E System (2)
