WIND SYSTEMS TECHNICAL NOTES: 1979-1980

Rocky Flats
Wind Systems Program

CONTROLLED VELOCITY TESTING
OF THE
ASI/PINSON HIGH RELIABILITY WIND TURBINE GENERATOR

TN-80-13

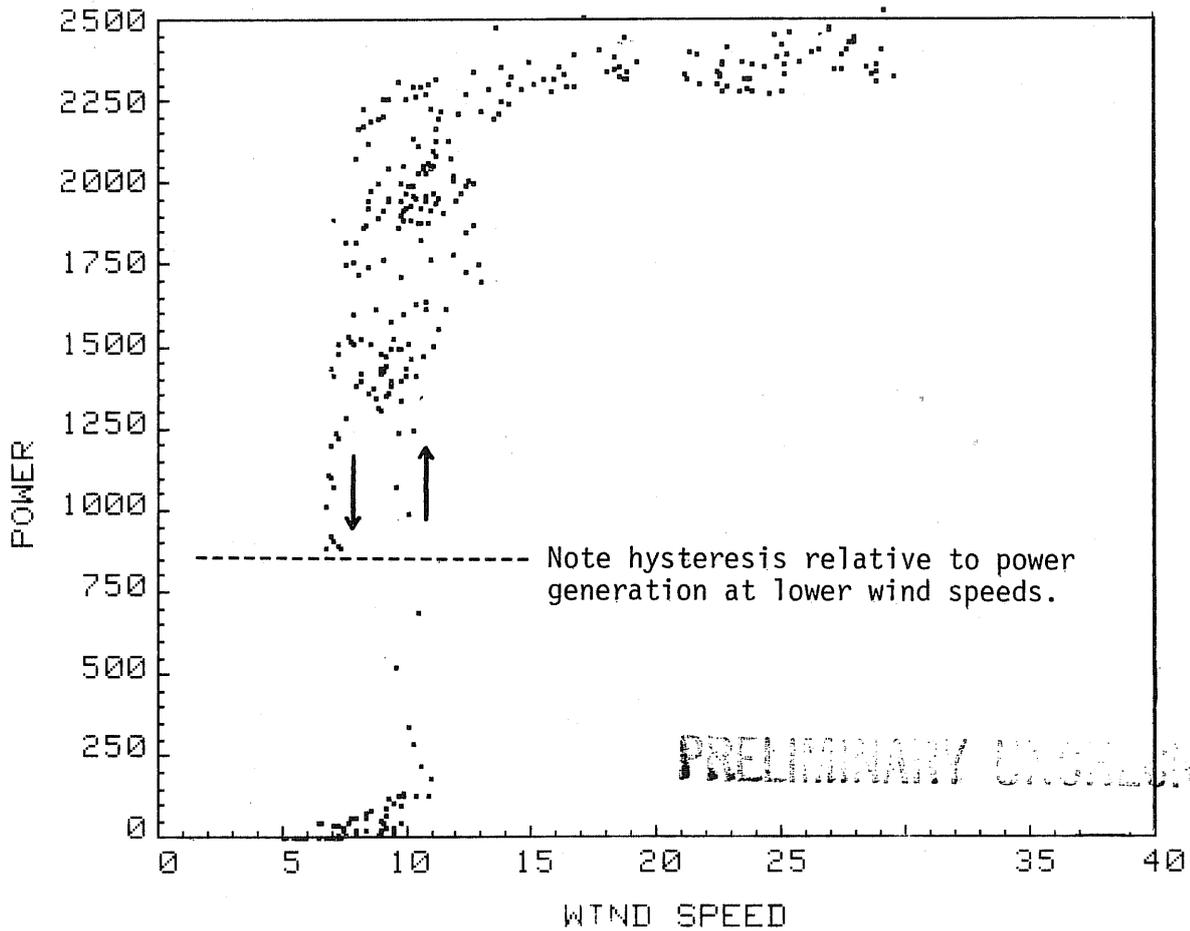
FIGURE 2
OVERSPEED CONDITION

When CVT of the ASI/Pinson began, immediate attempts were made to adjust the cut-out point to the recommended 160 rpm. Several runs were made after adjusting the trip mechanism between each run. However, results were not consistent (i.e., they did not always reflect the direction of the adjustment). During one run, an overspeed condition caused the rotor to reach 235 rpm, and several rivets that tie the blade skin to the extruded leading edge "popped" 171

out of blades 2 and 3. Figure 2 reflects power data generated during this time frame. Data collection continued beyond the maximum rpm and power points through shutdown and almost to complete stop. It is felt that high centrifugal and aerodynamic loads caused the rivet failures, and an investigation is planned to establish the pull strengths of the rivets. After new rivets were installed, another test was made to verify the cut-out point. This test run resulted in the same overspeed condition and the test was stopped.

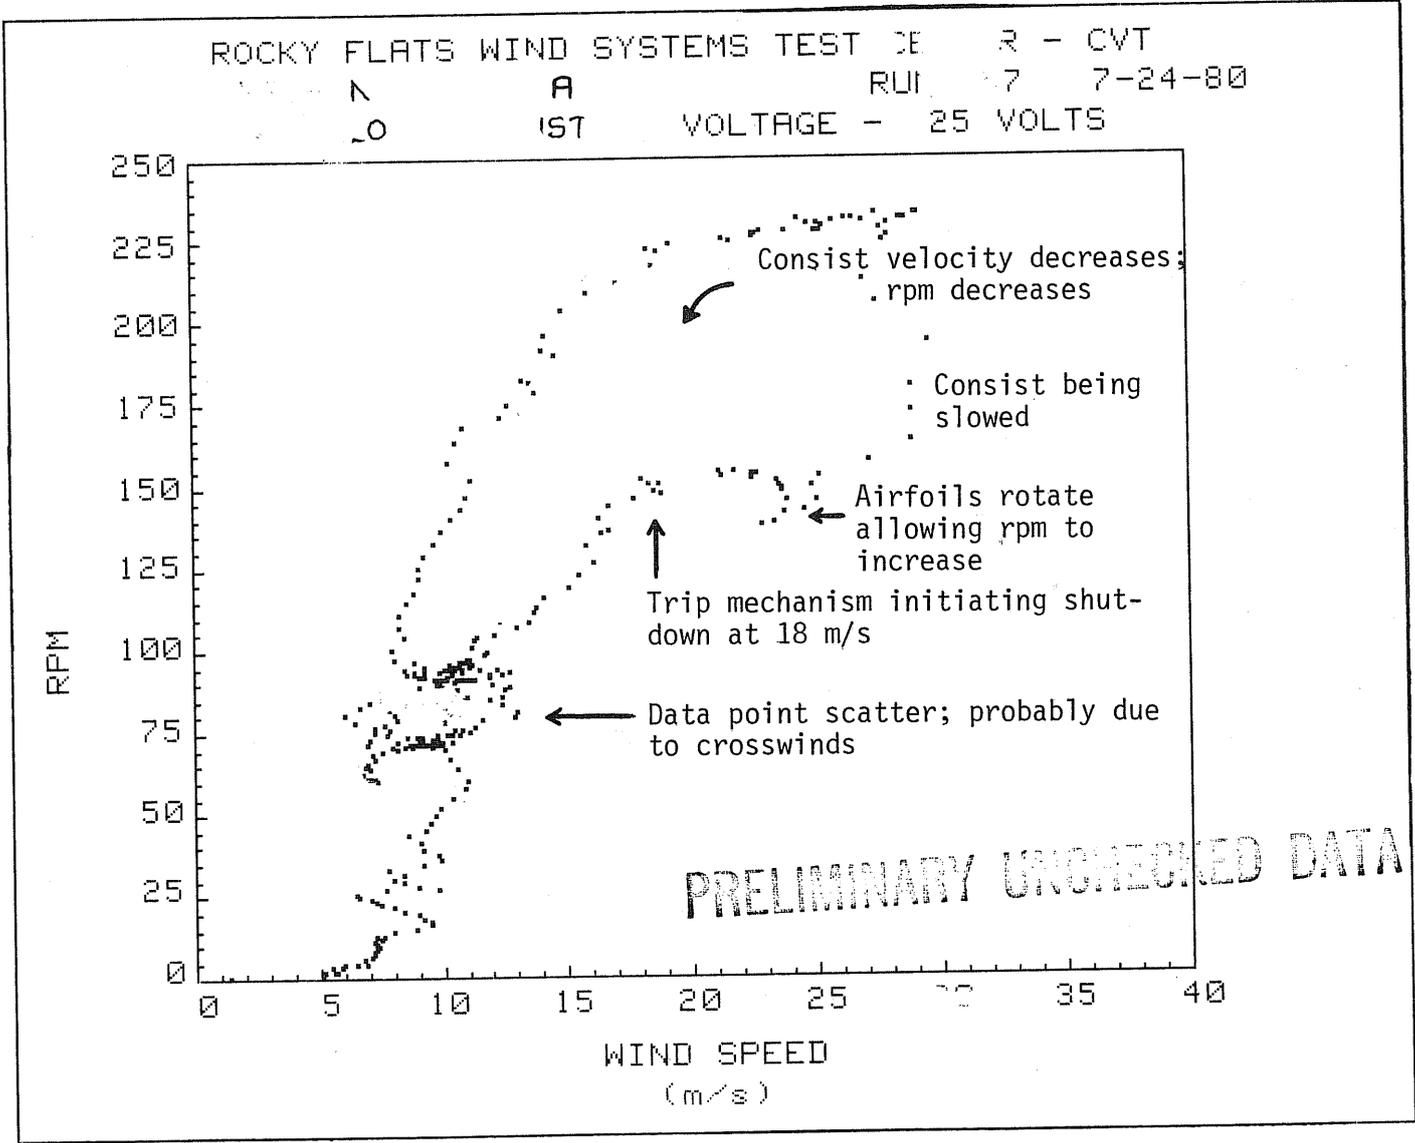
FIGURE 3
 OVERSPEED CONDITION

Examination revealed that the airfoils on the "V"-vane tail assembly had rotated about their single attachment point to the tail boom. The trailing edges had moved approximately 4 inches apart, in comparison to a starting point of less than 1/4" apart. This movement decreased the angle of attack and amount of lift required to actuate the trip mechanism for shutdown. Figure 3 presents rpm data generated just prior to discovery of the airfoil rotation with critical points noted. Figure 3 plainly shows the trip mechanism starting to shut down at a windspeed of approximately 18 m/s (40 mph). Then, the airfoils apparently rotated and allowed the rotor to run up to 235 rpm in approximately 10 seconds. The test run was stopped at this point.

Repair was initiated consisting of two 2" sheet metal straps extending between the two airfoils and across the boom. One strap was located just ahead of the attachment point, the other at the trailing edge. The airfoils were rotated such that the trailing edges were nearly touching.

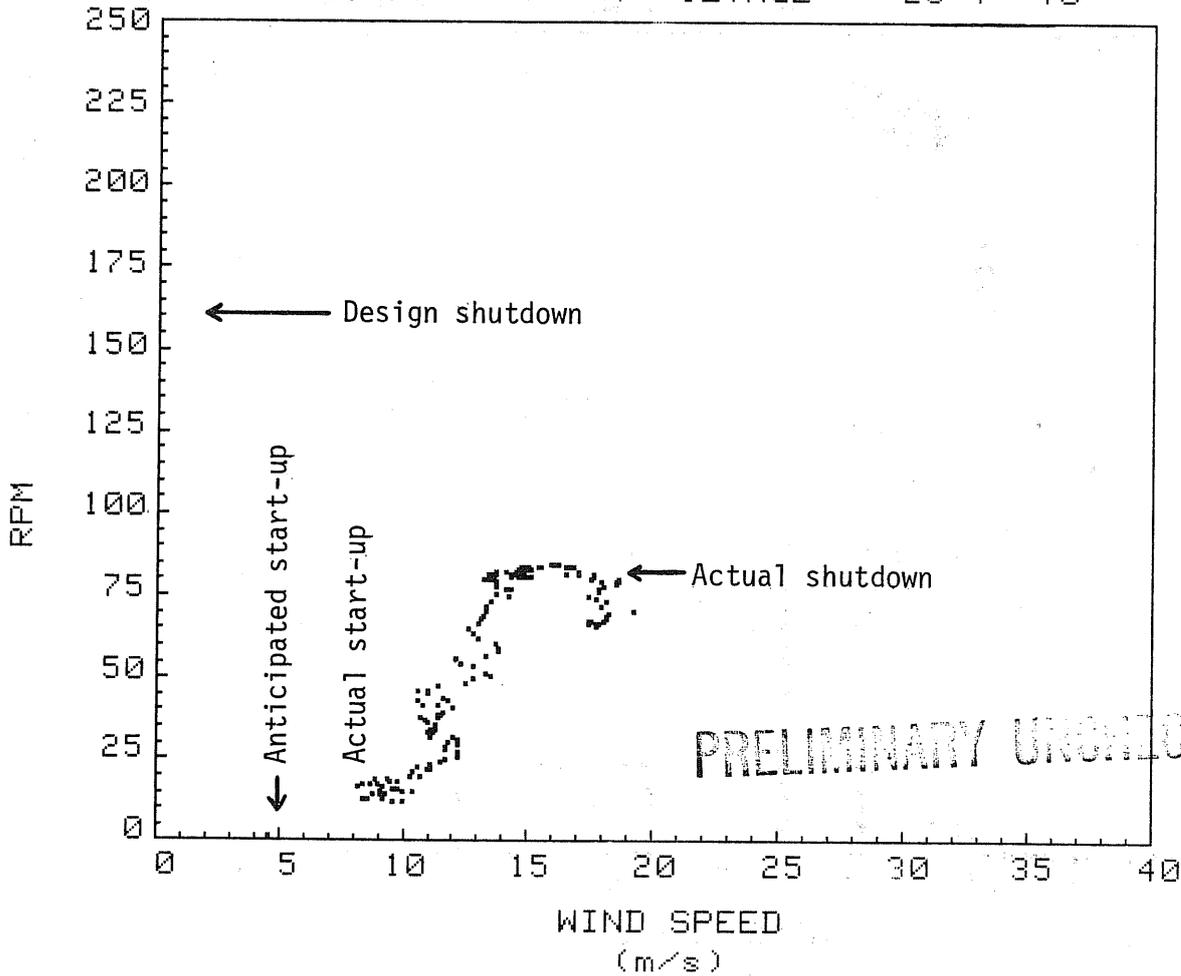
FIGURE 4
EARLY SHUTDOWN

After making several additional test runs with the modification, it was evident that the cut-out rpm was now far too low, although the cut-out wind speed was normal (Figure 4). A number of trip mechanism adjustments produced no improvement. A close examination of the trip mechanism revealed that the locknut holding the threaded rod (bolt) in the actuator rod swivel had worked loose. This shortened the stroke of the actuator rod and the remainder of the trip mechanism. The locknut was tightened and a few more runs were made to locate the cut-out point. In this configuration, the machine would go into a deep stall and nearly stop rotating. Power and rpm data reflected in Figures 5 and 6, respectively, were generated after tightening the loose swivel locknut. These data reflect a significantly high cut-in wind speed (10 m/s) and low cut-out wind speed (15 m/s).

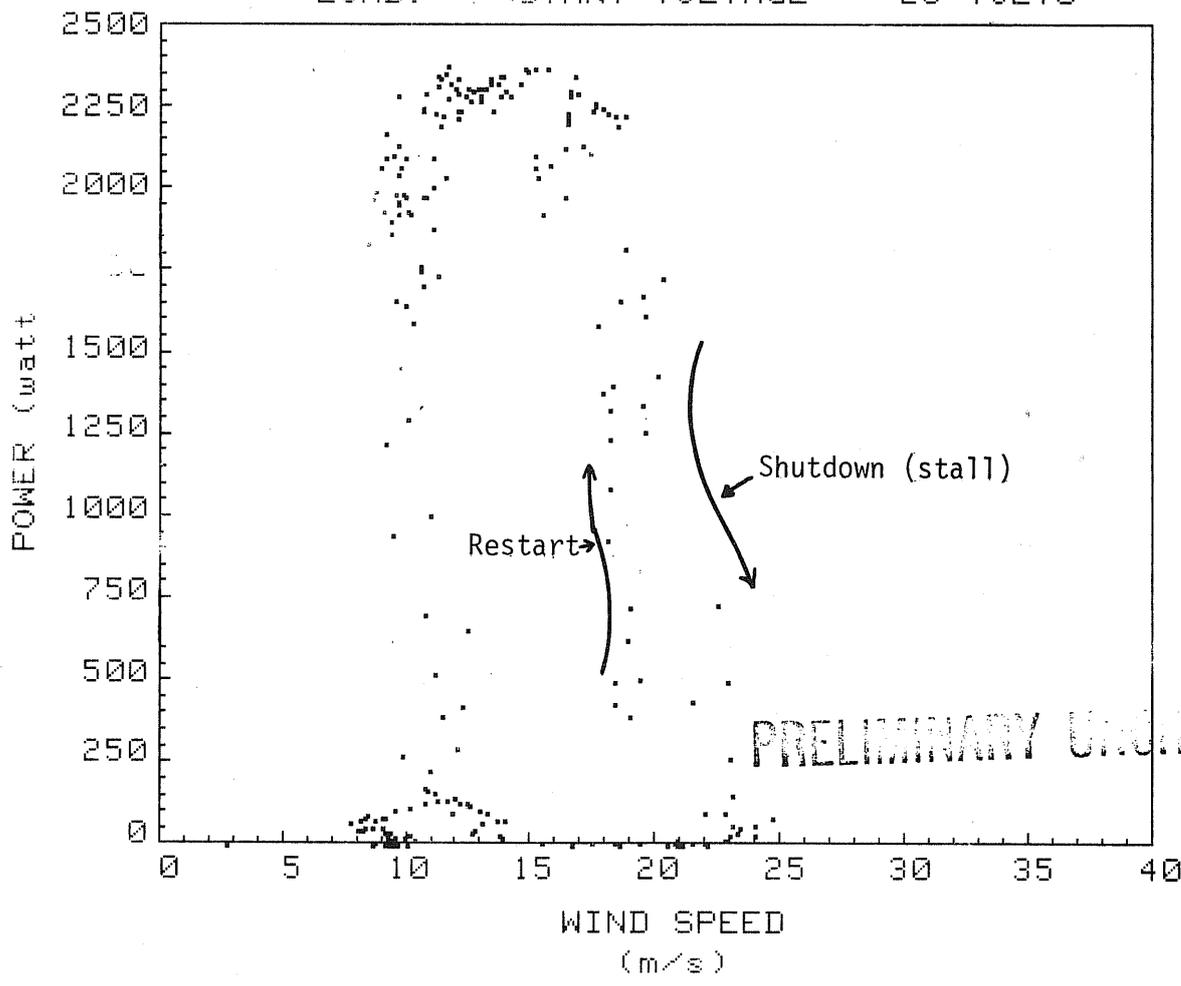
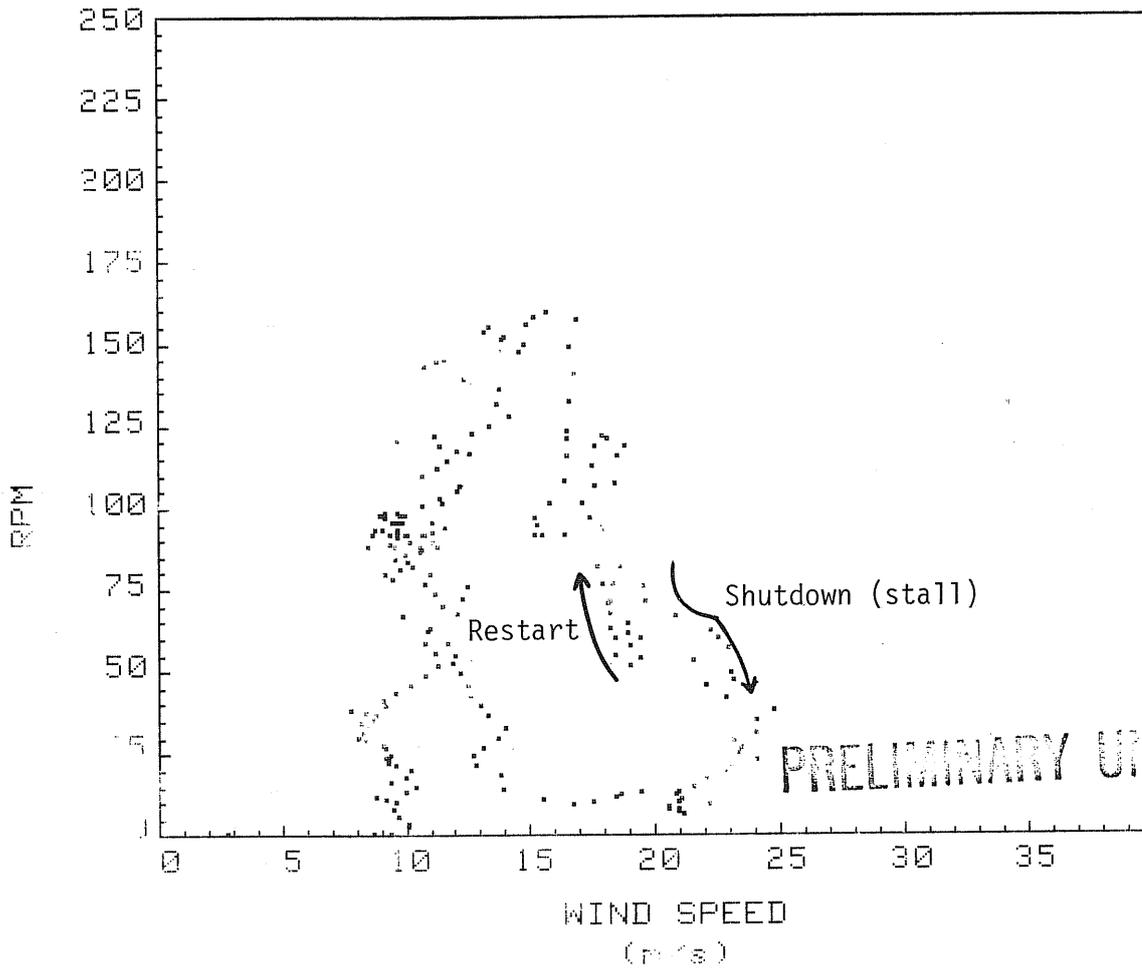
The tail was again modified to allow a 2" separation between the airfoil trailing edges (roughly the mid-point of the previous configurations). Several more runs and one additional adjustment of the trip mechanism indicated the WTG was then operating normally and further testing could be performed. Figures 7 and 8 contain data generated during testing in this configuration with the trip mechanism adjusted for shutdown at an rpm of just under 160. Note that the WTG restarted after shutdown. This configuration was kept for the remainder of the tests, and cut-in and cut-out were re-checked and re-verified. Figures 9 through 12 are plots of data generated on the same run as Figures 7 and 8 after using the "Method of Bins." These data (Figures 9 through 12) indicate that shutdown occurs at the proper rpm, but just above a wind velocity of 13.4 m/s (30 mph). Design shutdown wind velocity is approximately 17.9 m/s (40 mph). Also note that maximum C_p and power do not occur at the same wind speed. This could indicate an improper match between the rotor and load. Table II is a summary of all problem areas encountered during CVT of the ASI/Pinson.

FIGURE 7
WTG NORMAL - RPM REGULATED ABOVE SHUTDOWN
