McDONNELL 40 kW GIROMILL WIND SYSTEM

Phase II Fabrication and Test

JUNE 1980

McDONNELL AIRCRAFT COMPANY
P.O. Box 516
St. Louis, Missouri 63166

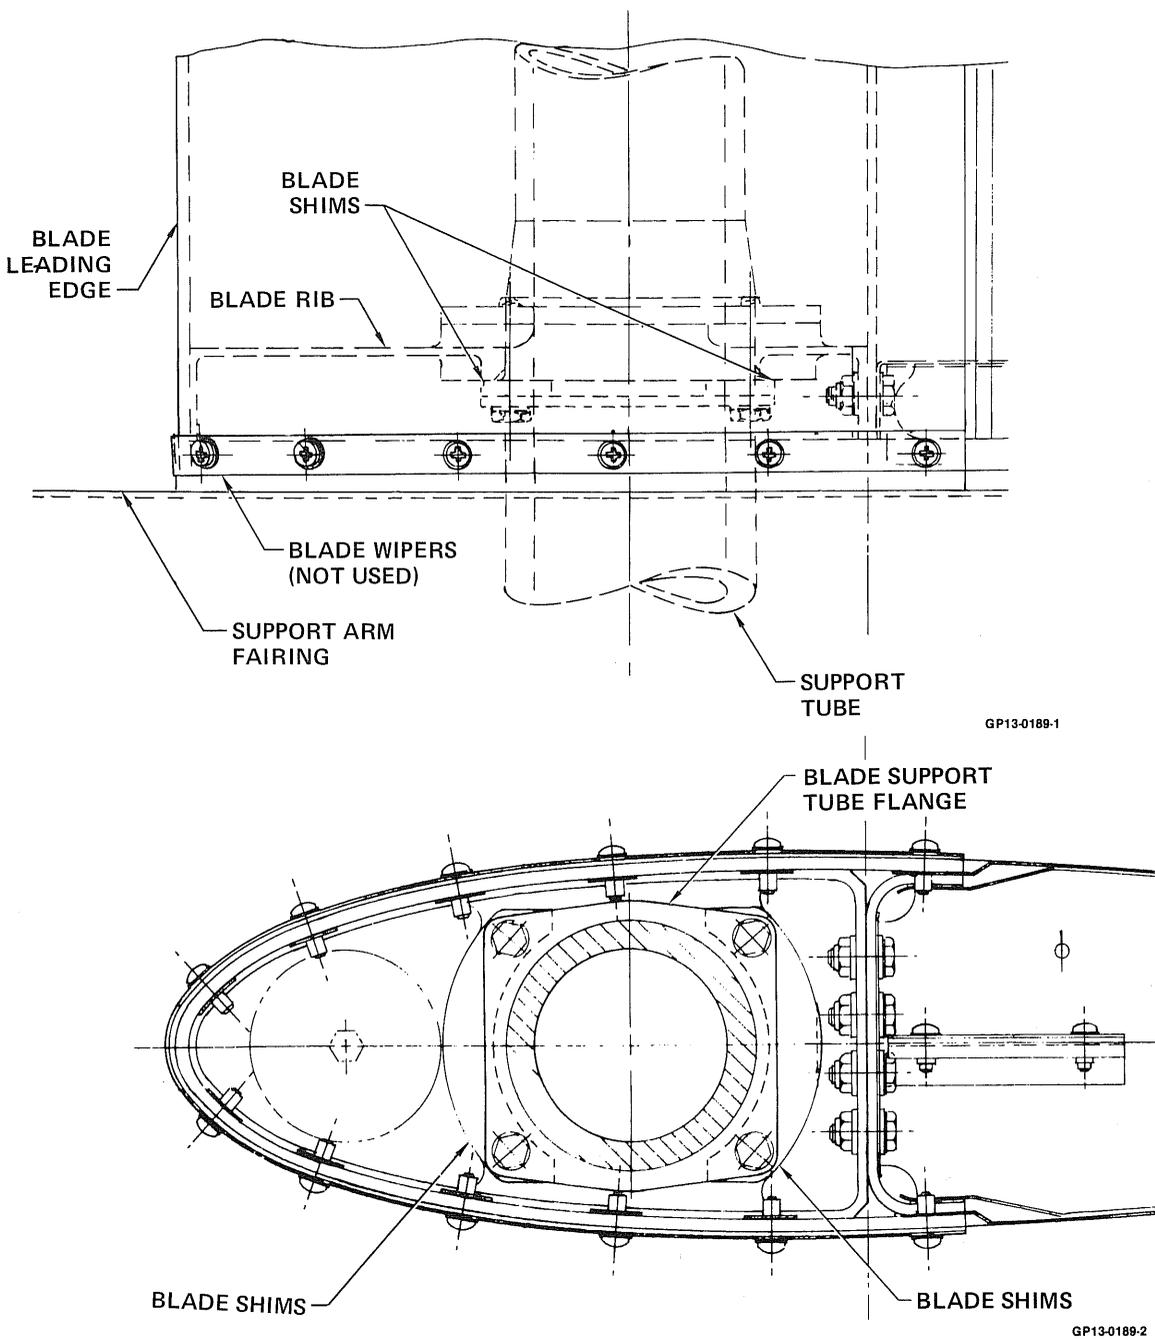
Blade Shims - When assembling the Giromill it was determined that tolerances could add up and cause the blades to rub against the support arm fairings. To increase the clearance, blade shims were made to fit between the blade support tube mounting flange and the blade rib, as shown in Figure 30. Shims having a thickness of 3/16 or 1/4 inch were used as required to provide clearance. MCAIR Drawing 71A090101 shows that change.

FIGURE 30
BLADE SHIMS FOR CLEARANCE

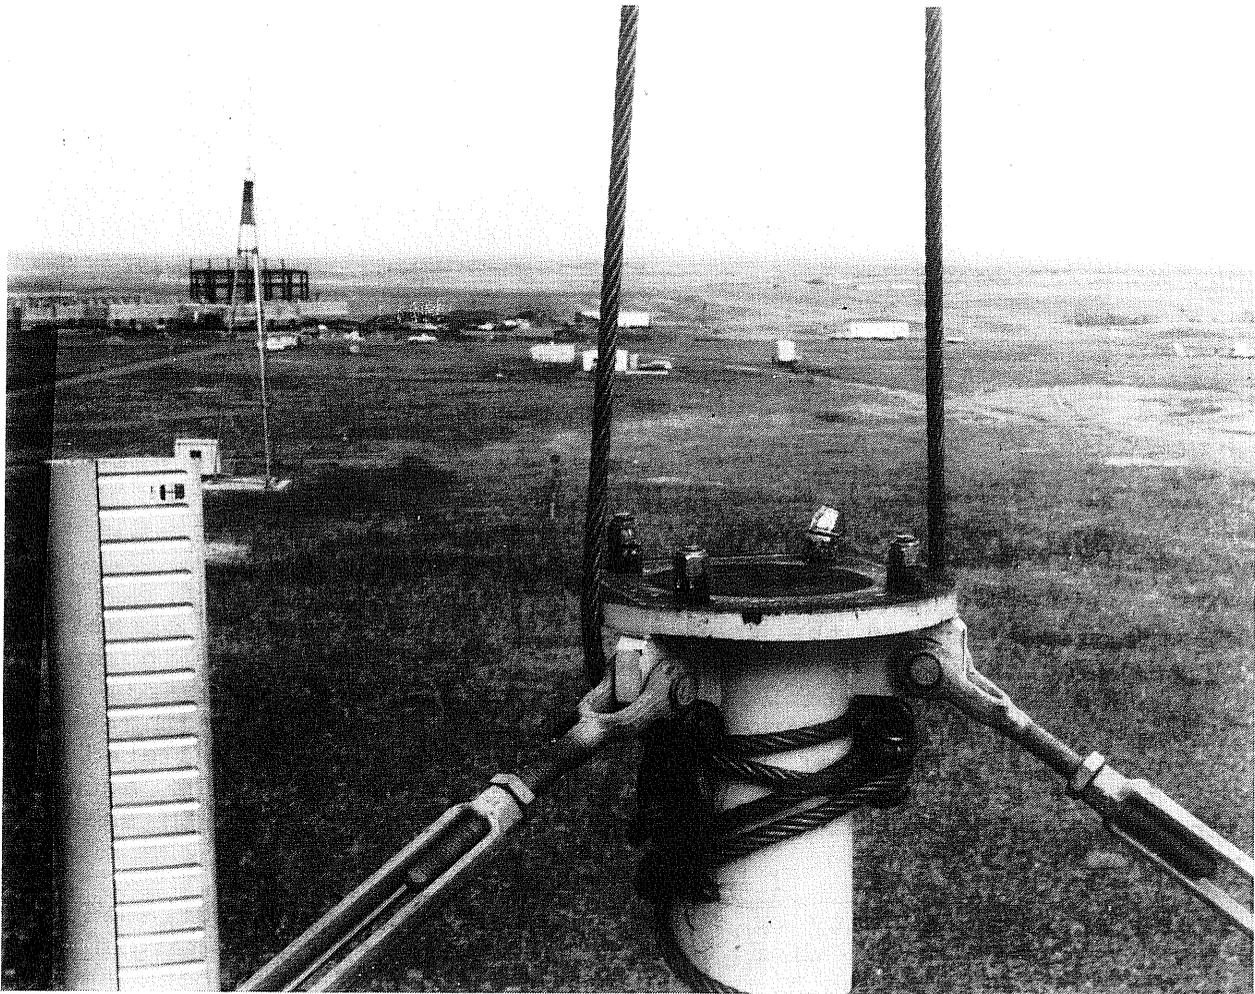
A visual inspection revealed that the nuts had pulled through the washers, allowing the bolts, nuts, and spacers to pass through the holes in the base of the pole and remain with the rotating tower as shown in Figure 39. The washers were partially extruded into the pole base holes, as shown in Figure 40, indicating that the washers failed in shear. In addition, paint was chipped along the weld line attaching the pole tube to the base plate indicating possible high oscillatory loads.

FIGURE 39
LIGHTNING POLE-TO-ROTATING TOWER INTERFACE JOINT

The location of the pole on the ground after the accident indicated that the attach bolts failed while the Giromill was running. The wind speed at the time of failure was probably 40-45 MPH (possibly 5 MPH over cut-off speed). Since considerable margins of safety exist for the joint at this wind velocity, it is speculated that dynamic forces added to the wind drag loads on the pole to cause failure. These forces could have resulted from a soft spring constant of the joint, from a loose joint at the pole base caused by bending of the washers from previous high wind loads, from spacers too long to allow proper seating of nuts, or from insufficient torque on the nuts.

The lightning pole attachment failed during Giromill operation damaging a blade and two support arms (See Section 6.3.1). Because of this carbon brushes with high copper content were installed to shunt the current around the bearing. The brush installation is shown on MCAIR Drawing 71A090101. Removal of the lightning protection pole is reflected in Valley Drawing 40102.

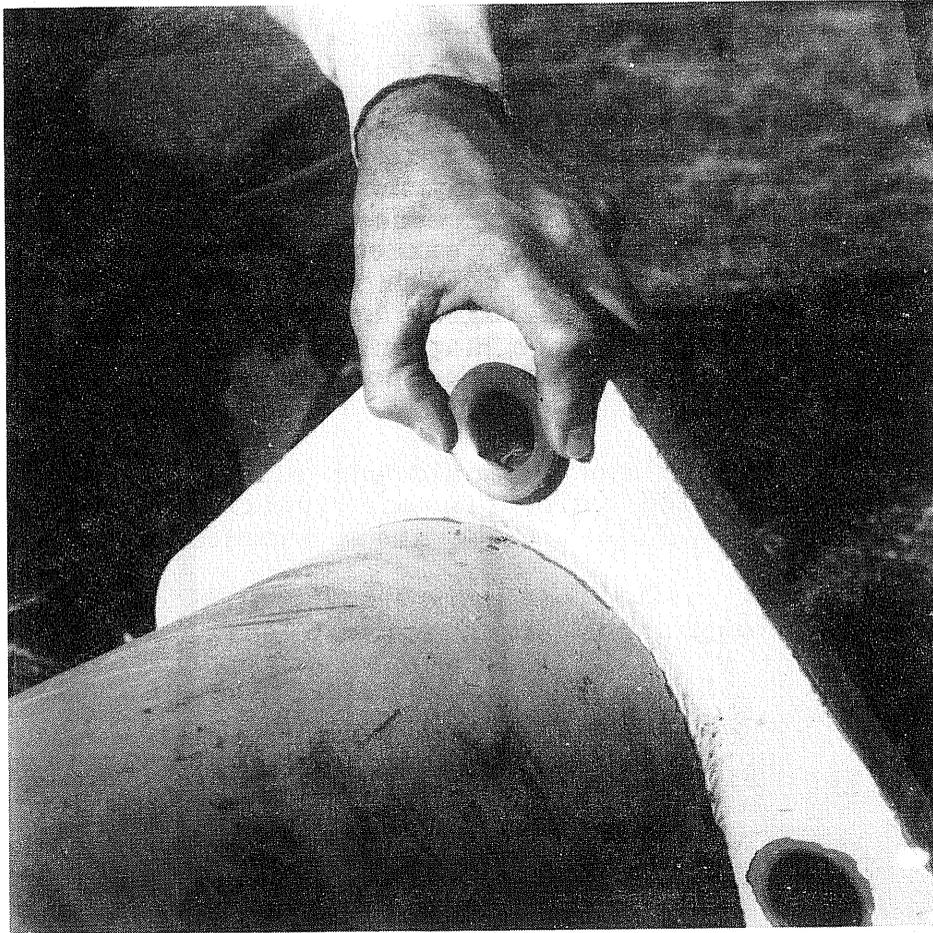
FIGURE 40
WASHER PARTIALLY EXTRUDED INTO HOLE

The location of the load is based on measurements of markings on the failed washer. As the washer deflects under increasing load, this point of load application would move towards the bolt centerline, reducing the eccentricity for bending and approaching a pure shear loading. Bending stresses calculated in the manner described will therefore be higher than the actual stresses. (The actual failure mode of the washer was in shear, as shown in Figure 40.)

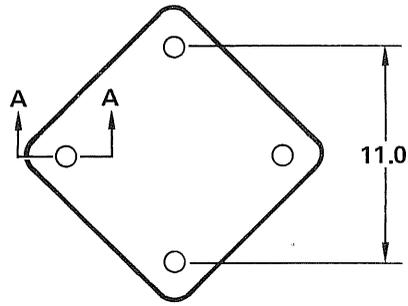
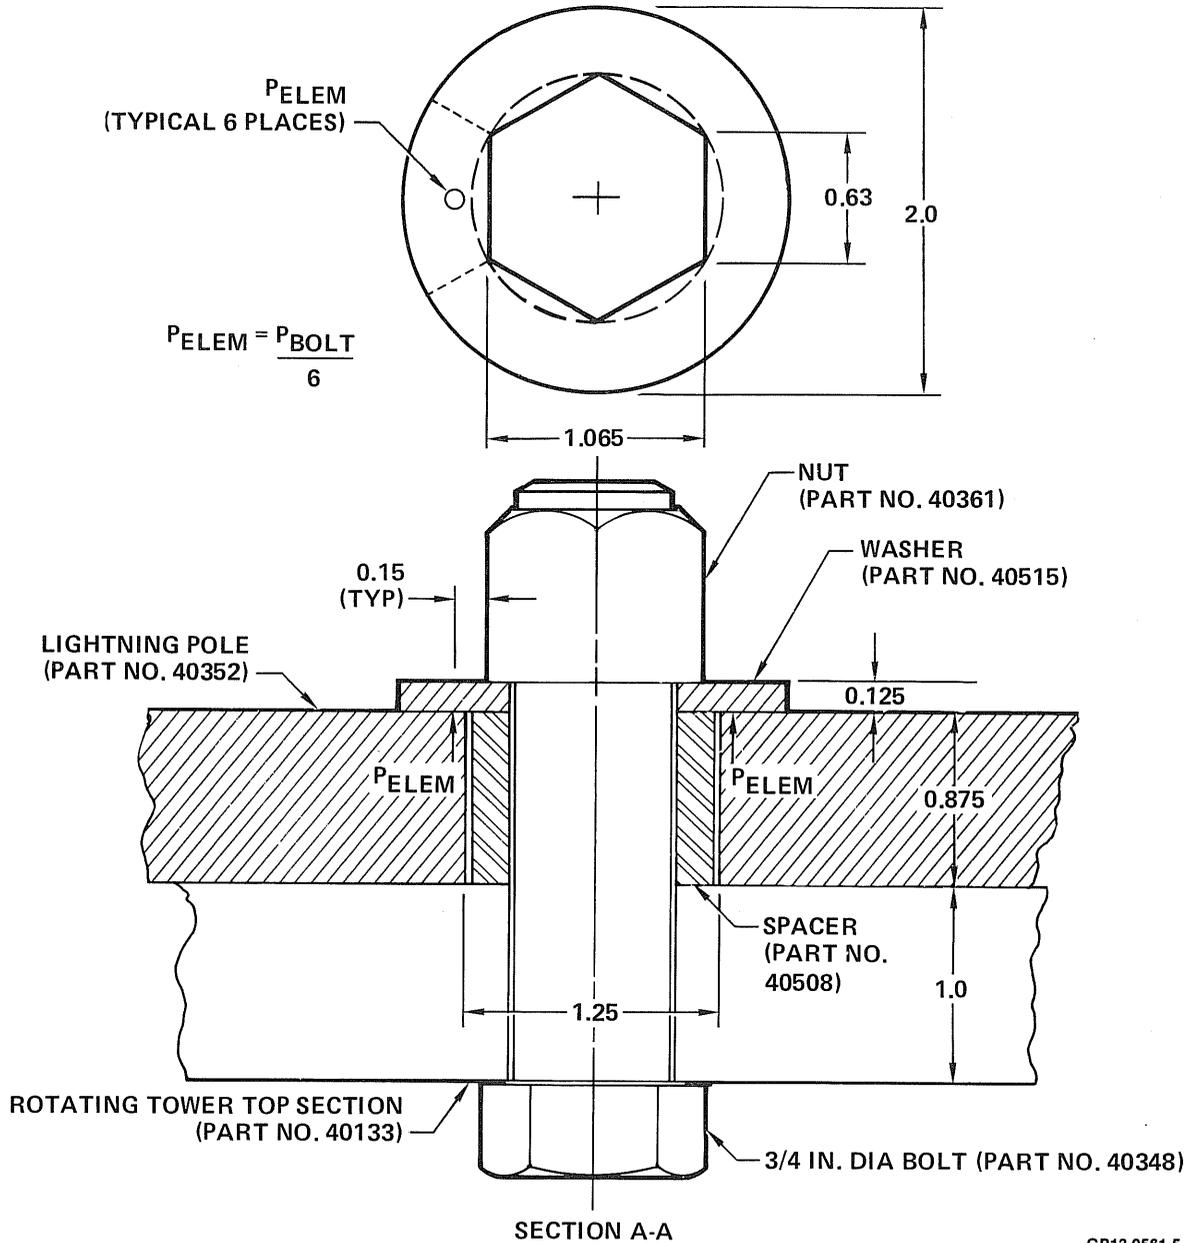
LIGHTNING POLE BOLT PATTERN

In order to analyze the failure of the washers, bolt loads were calculated for several wind velocities up to 125 MPH. The bolt pattern at the pole-to-tower interface and a cross-section

through an attach bolt is shown in Figure 41. Bolts were assumed to react to the pole root bending moment as a couple between bolts at diagonally opposite corners. Figure 42 lists, for each incremental wind velocity, the total drag load, root bending moment on the pole, and the maximum individual bolt load.

Bending and shear stresses on the washer are plotted versus wind velocity in Figure 43. Stresses were calculated assuming that the washer was divided into six equal segments, each segment being fixed at its intersection with the edge of the nut face. Thickness of the washer used in the analysis was scaled from an actual part. Bending of each segment was caused by an upward force on the washer applied by the pole base as shown in Figure 41.

FIGURE 41
LIGHTNING POLE-TO-ROTATING TOWER INTERFACE GEOMETRY

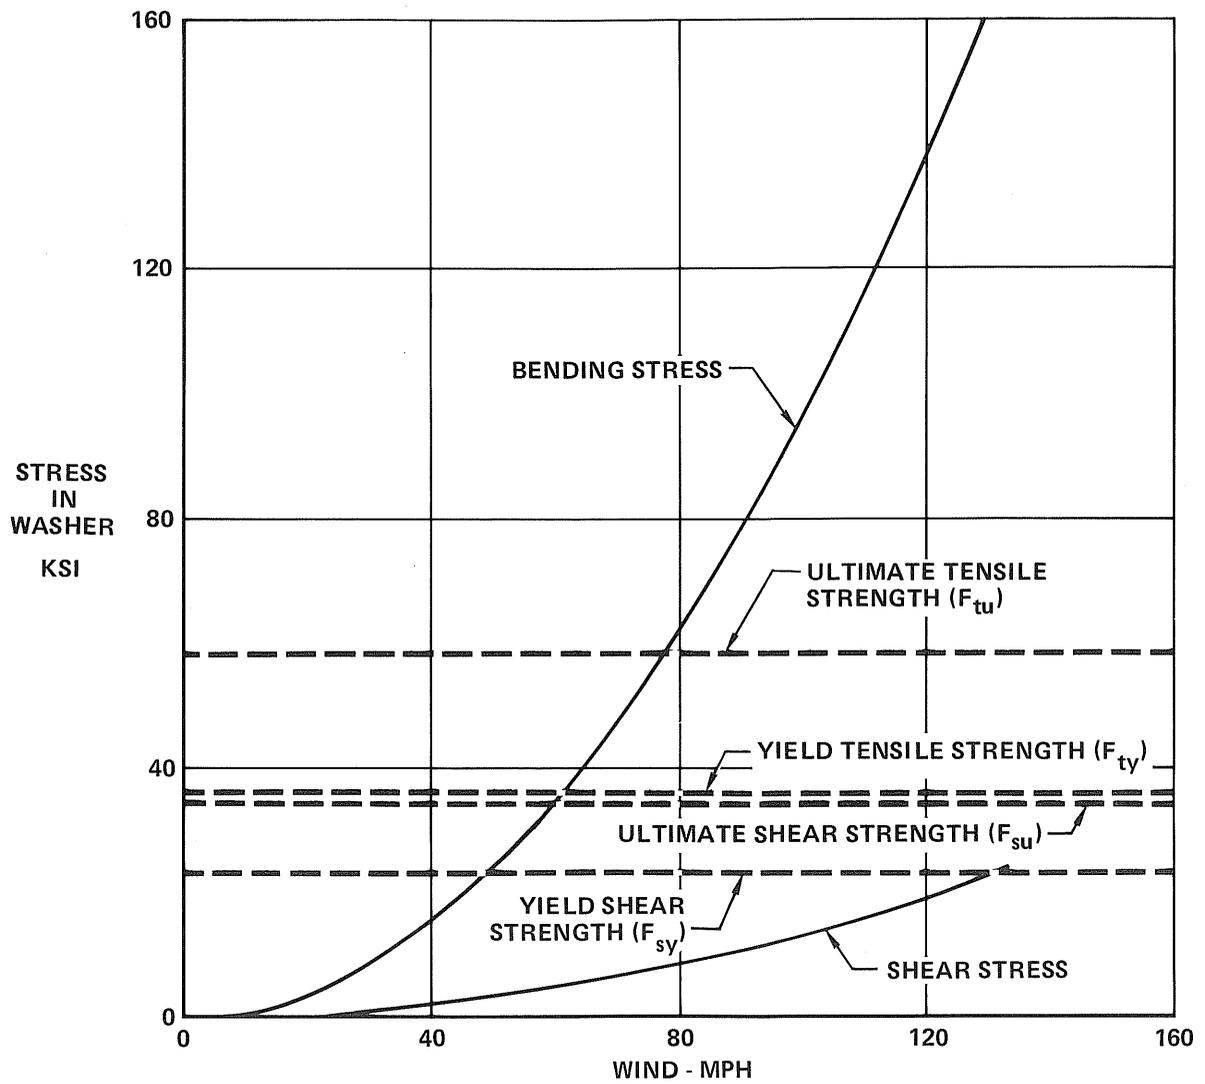
At a wind velocity of 40 mph, the Giromill is programmed to shut down. At this wind velocity, there is ample margin of safety on yield strength, as shown in Figure 42, for both shear and bending. A positive margin of safety exists on yield strengths for bending up to a wind velocity of 60 MPH. A positive margin of safety exists on yield strength for shear stresses up to a wind velocity of 130 MPH.

FIGURE 43
WASHER BENDING AND SHEAR STRESS

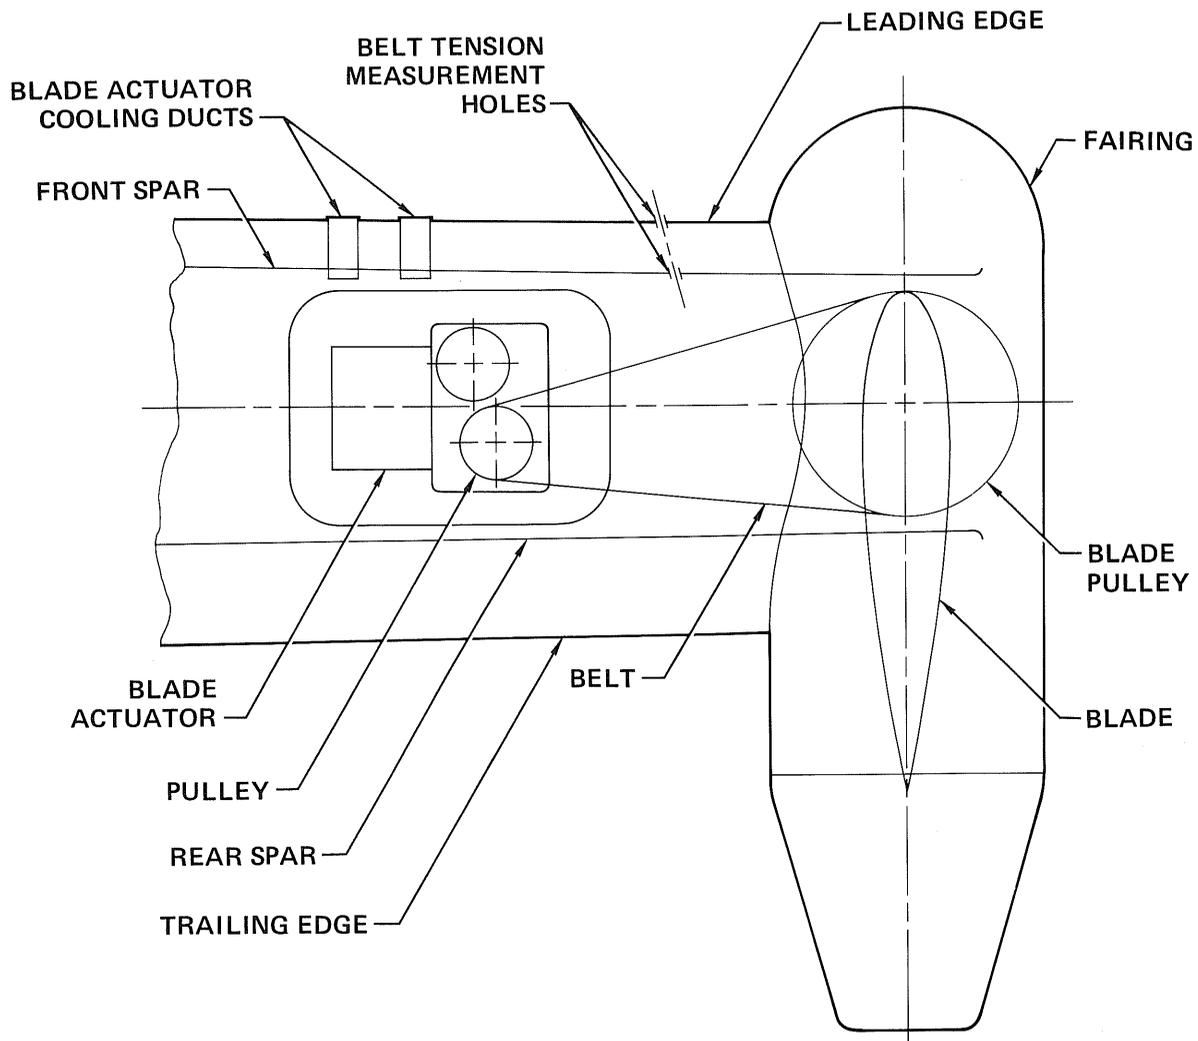
Actuator Pulley Loss - The actuators are connected to the blades by a toothed belt and pulley system. When the Giromill is running, the blade is continually being cycled back and forth by the actuator. This cyclic motion has resulted in the actuator pulleys coming loose and falling off. These pulleys are held on by a taper lock and keyway. The taper lock specification requires torquing the set screws to 175 in-lb while tapping the taper lock. To obtain the torque value is difficult, since the actuator will turn while the screws are being tightened. A strap wrench, that fits around the pulley, was used to hold the actuator while tightening the set screws.

FIGURE 44
BLADE ACTUATOR BELT TENSION MEASURING ACCESS HOLE

The belt specification indicates that when the belt is first installed it will stretch somewhat, and should be retightened after a few days. This should become a standard operating procedure.

To enable measurement of belt tension a belt access hole was drilled in the support arm, as shown in Figure 44. This hole is located near the belt mid span, and by inserting a 1/4 inch rod through the hole, belt tension and deflection can be measured using a belt tension tester such as is shown on Page 30-55, Reference 3. The force and deflection as measured by the tester should be 10 lbs for 0.44 inches deflection. This should give 500 lb tension in the belt.
