**Condition Monitoring on 47 meter
Wind turbines
by Jon Powers**

CalWind Projects: Wind Resource 1 Tehachapi, California

Condition Monitoring Turbines

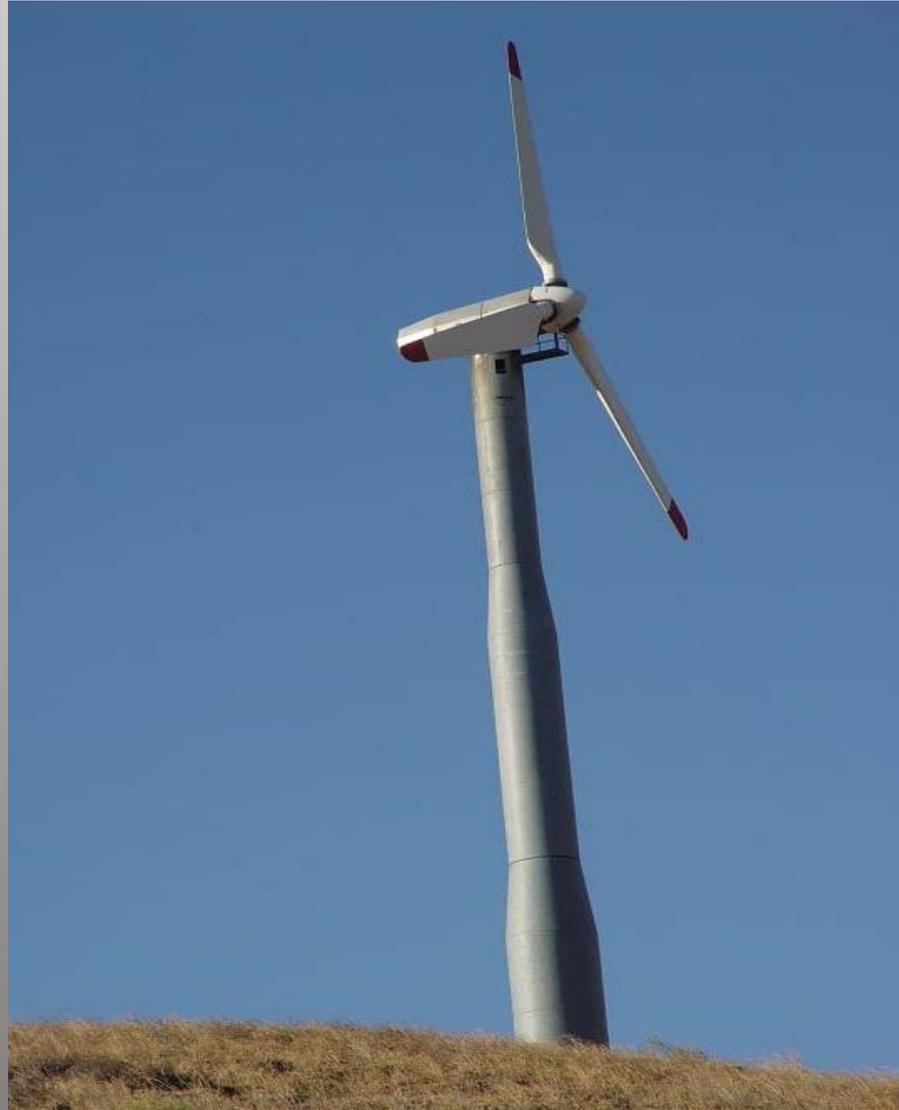
- 134 @ Nordtank 65/13 wind turbines installed 1984-85
- All wind turbines in current operation
- 9 Megawatt Facility

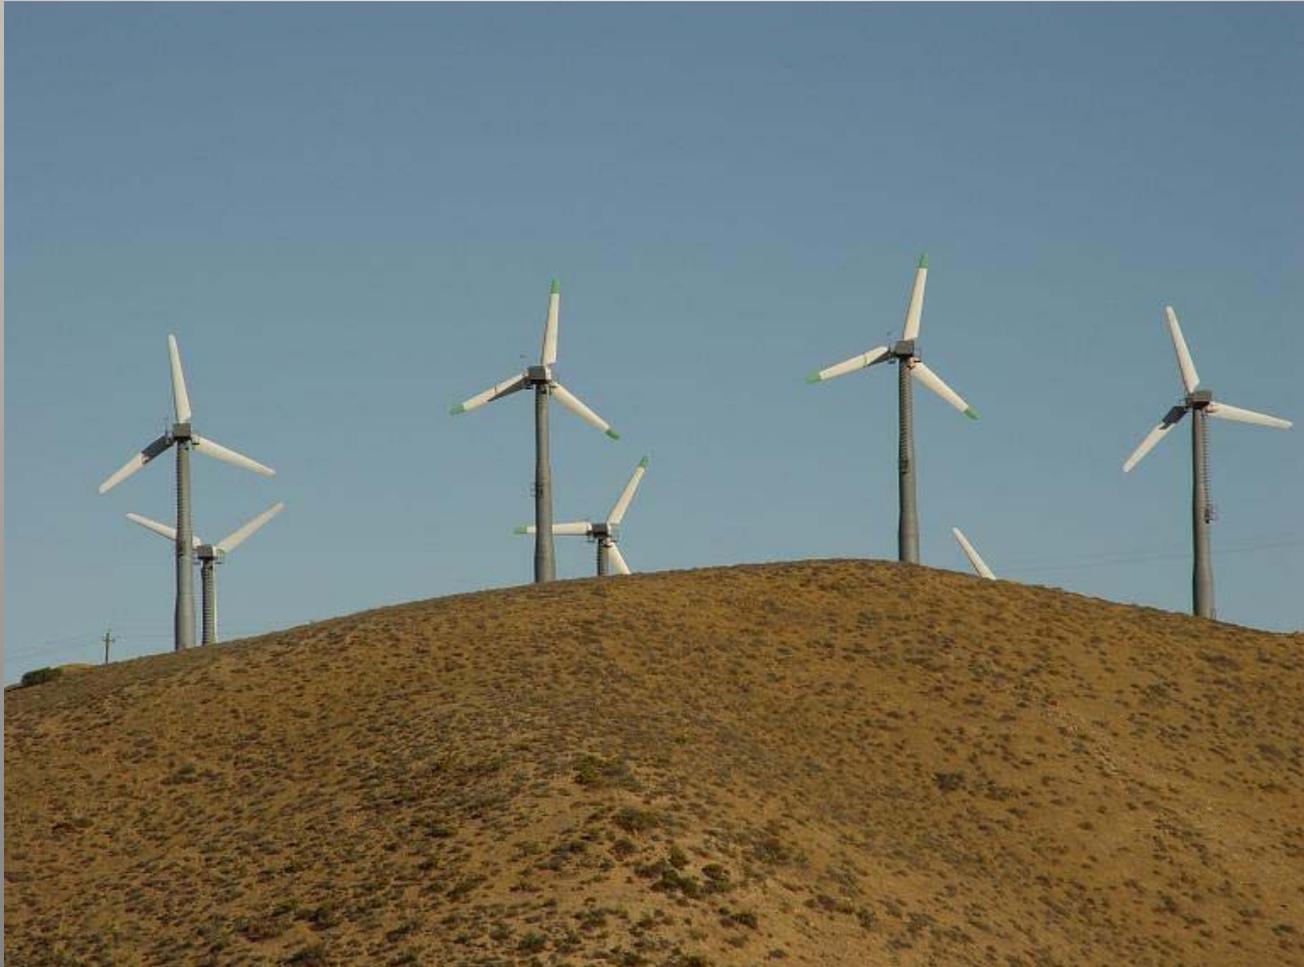
- 200+ @ Bonus 65/13 wind turbines installed 1983 to 1985
- Purchased & Operated by CalWind since 1997
- 22 Megawatt Facility

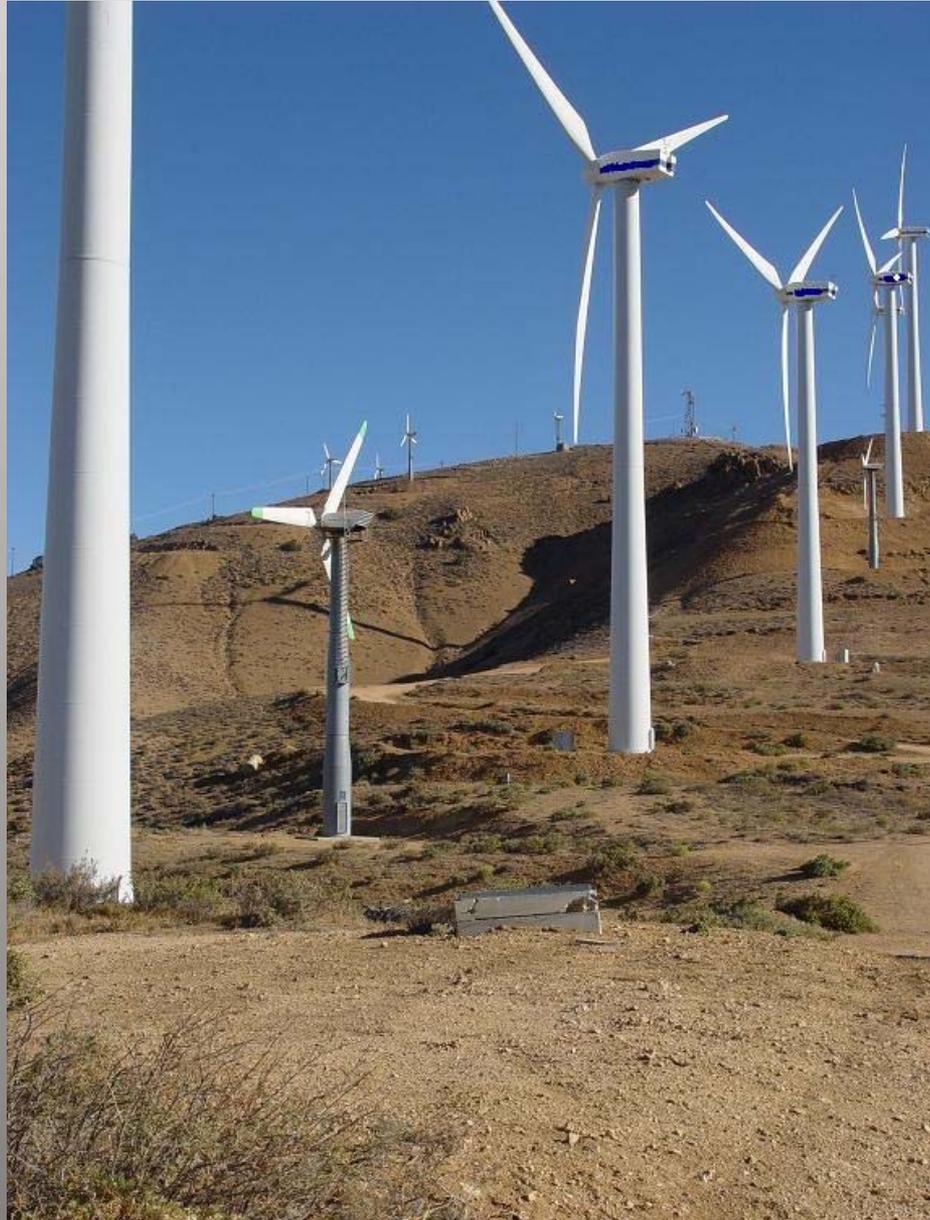
600+ KW Wind Turbine

- 13 @ 600+ KW wind turbines
- Operating for 6+ years
- Condition Monitoring for 2+ year

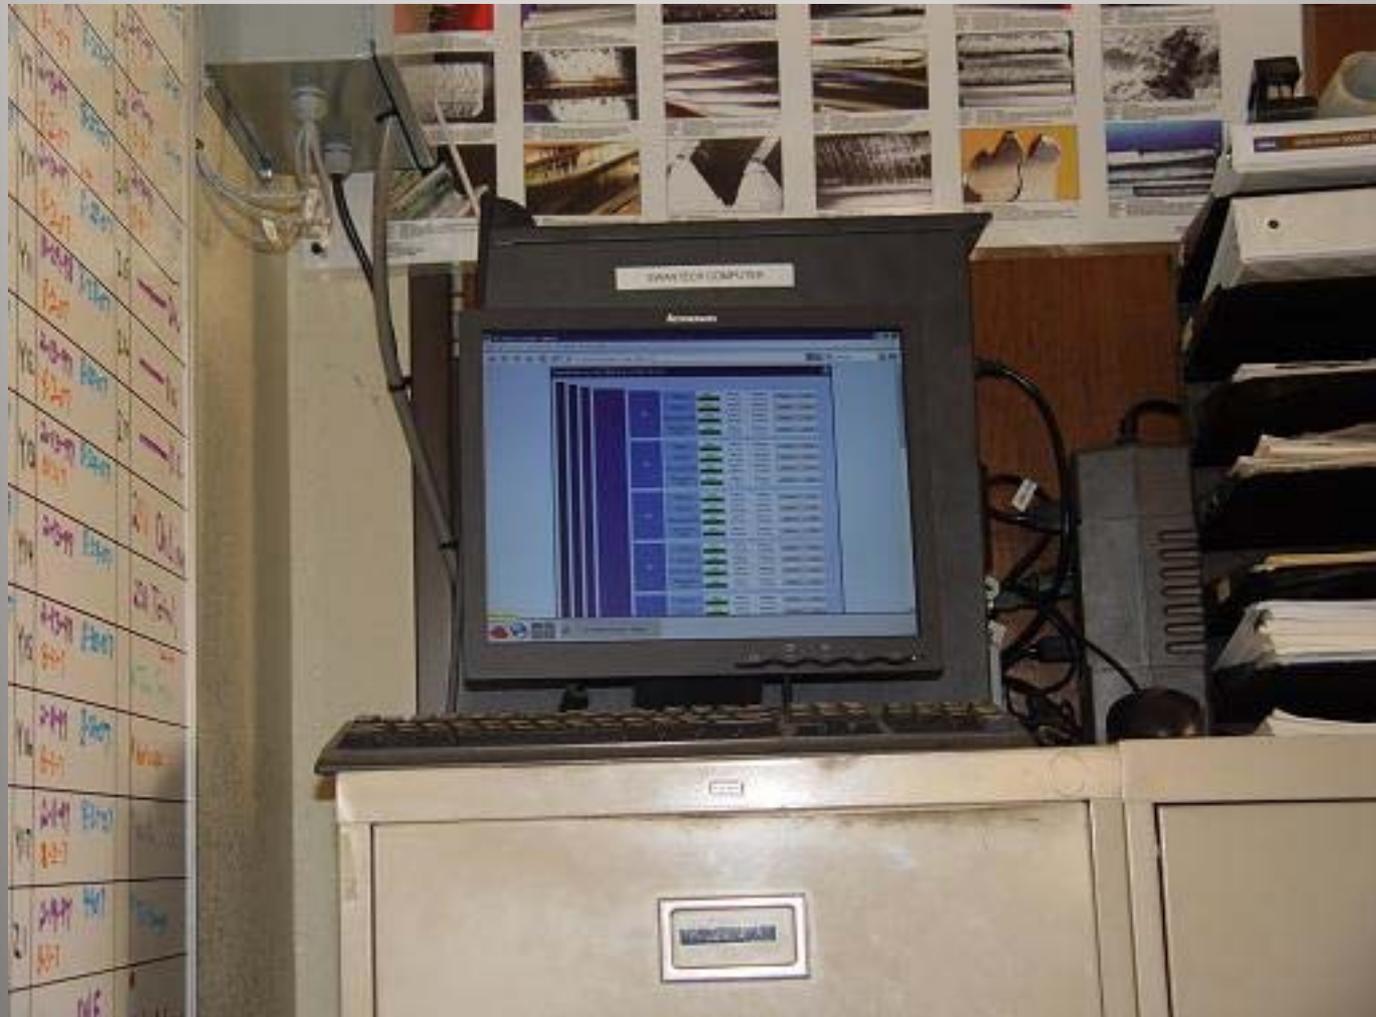
- Base Unit
- Base Radio Antenna
- Swan Guard
- Sensors on Gearbox
- Sensors on Generator
- Sensors on Yaw Drive & Main Shaft

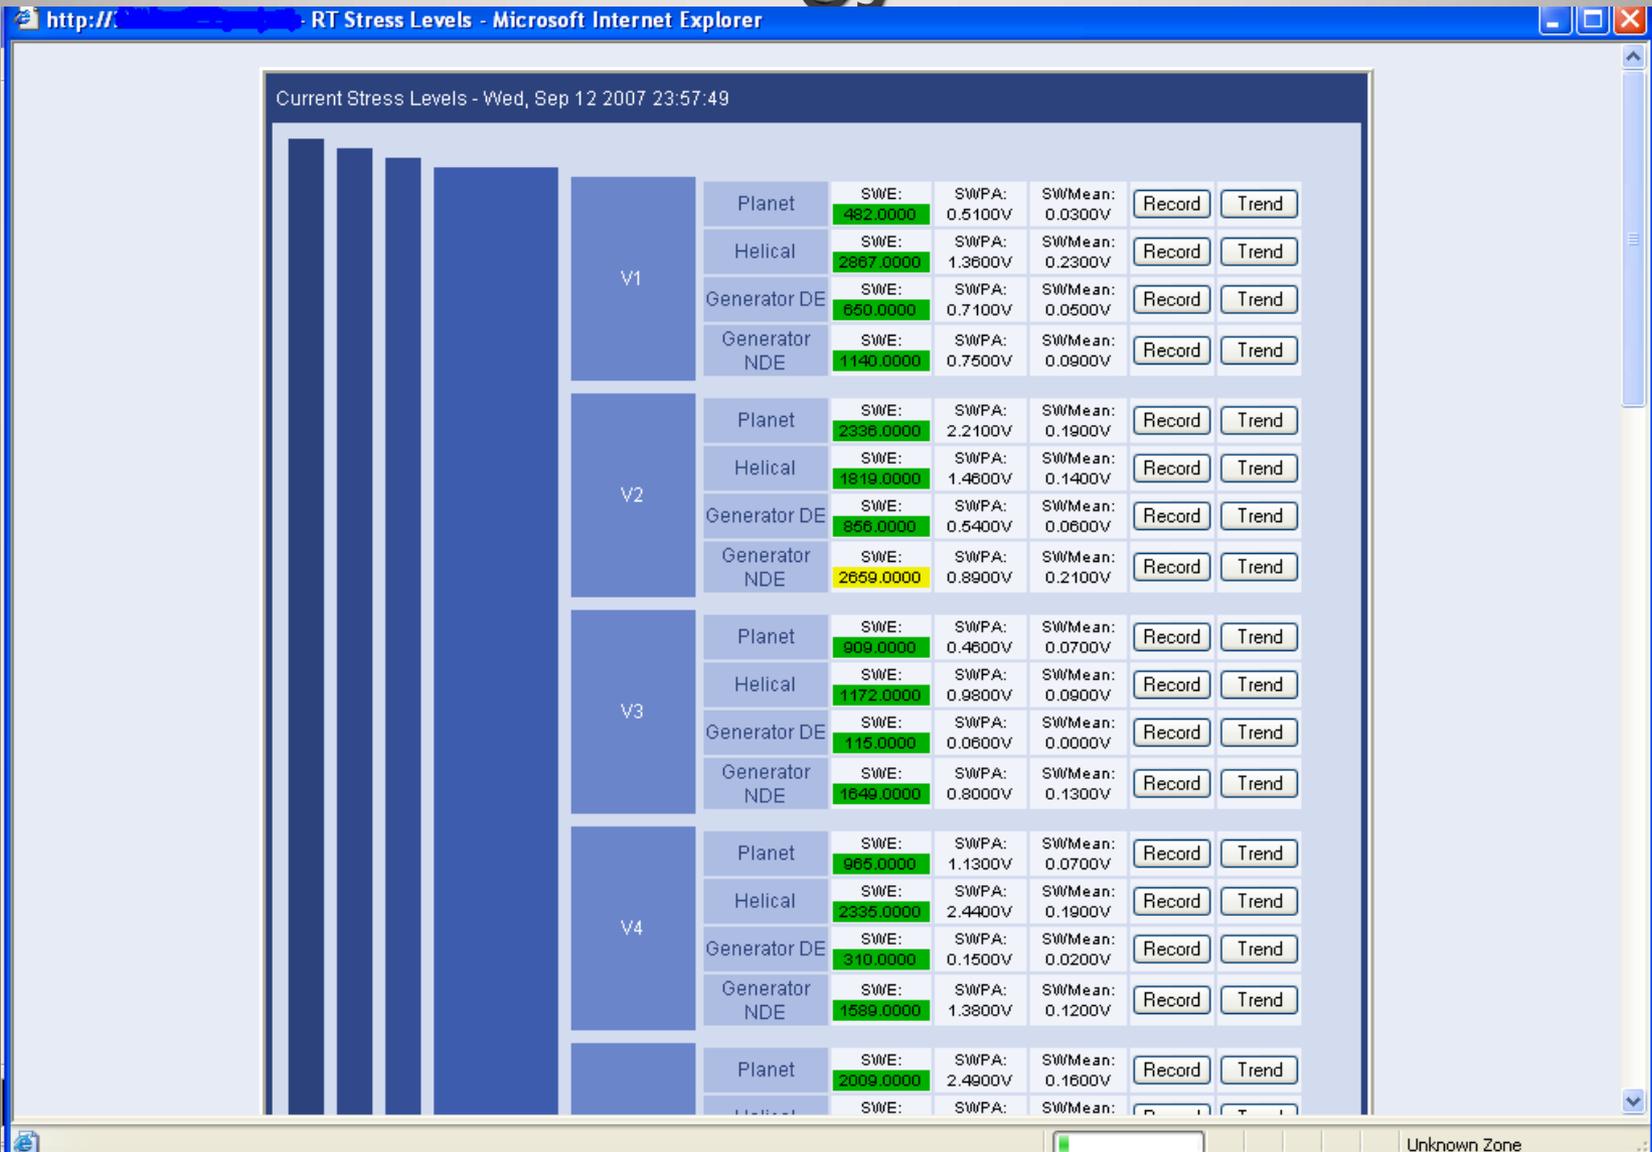
Swan Stress Energy Screen

- **Stress Wave Analysis (SWAN)** is a patented technology that provides measurement of overall machine health SWAN detects Stress Wave Energy that is created by shock and friction events SWAN enables the separation of these high frequency stress waves from the much lower range of operating machinery dynamics and audible noise, providing a clear indication of machine health.

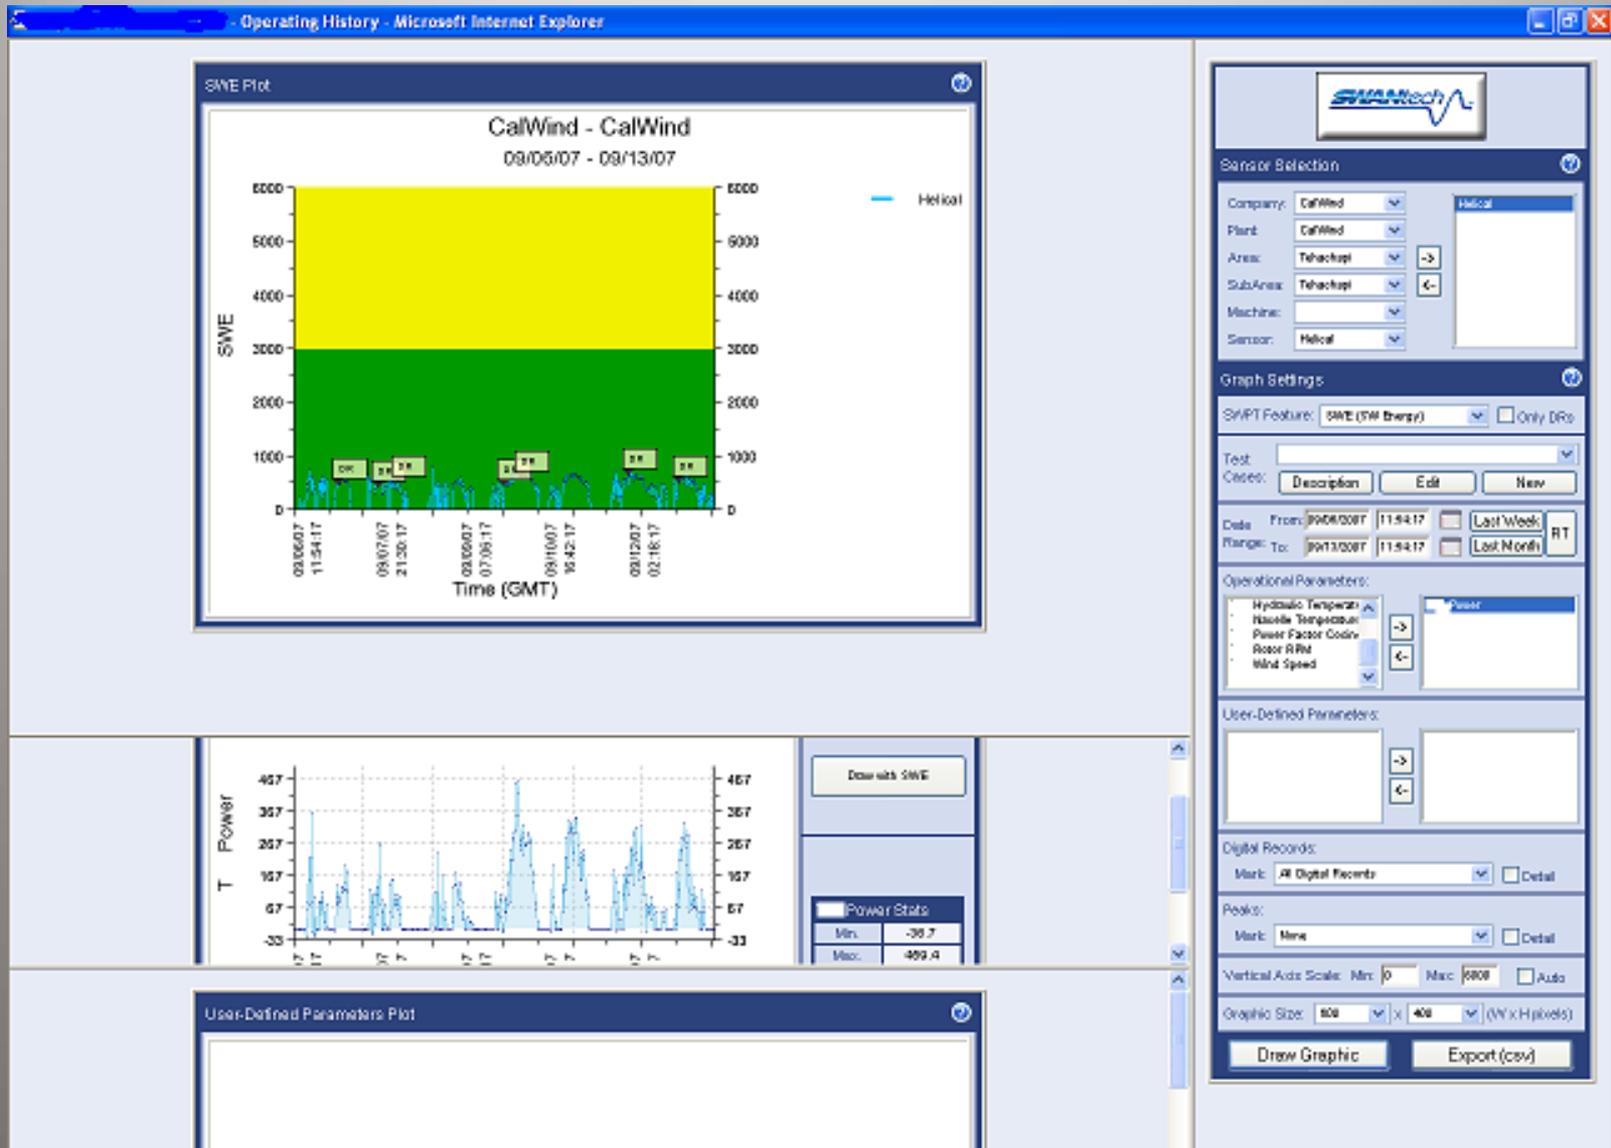
SWE Plot - Normal

Y-axis: SWE (0 to 14000)
X-axis: Time (GMT)

Y-axis: Power (-35 to 465)

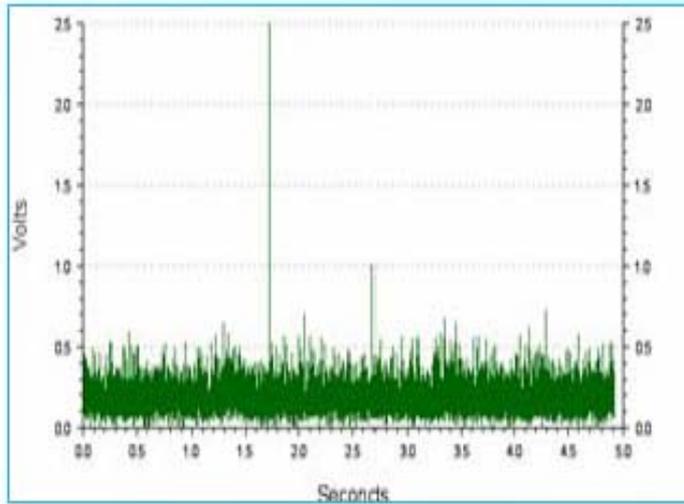
Generic Domain Time Series

Healthy

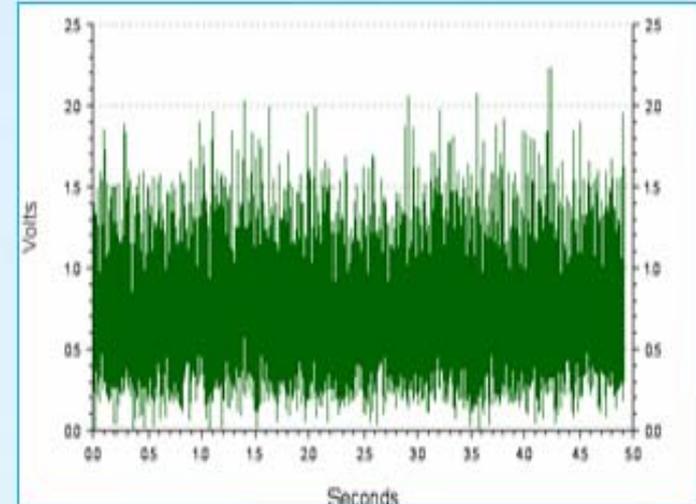
Random Friction

- Demodulated sensor signal
- Shows random friction and shock events

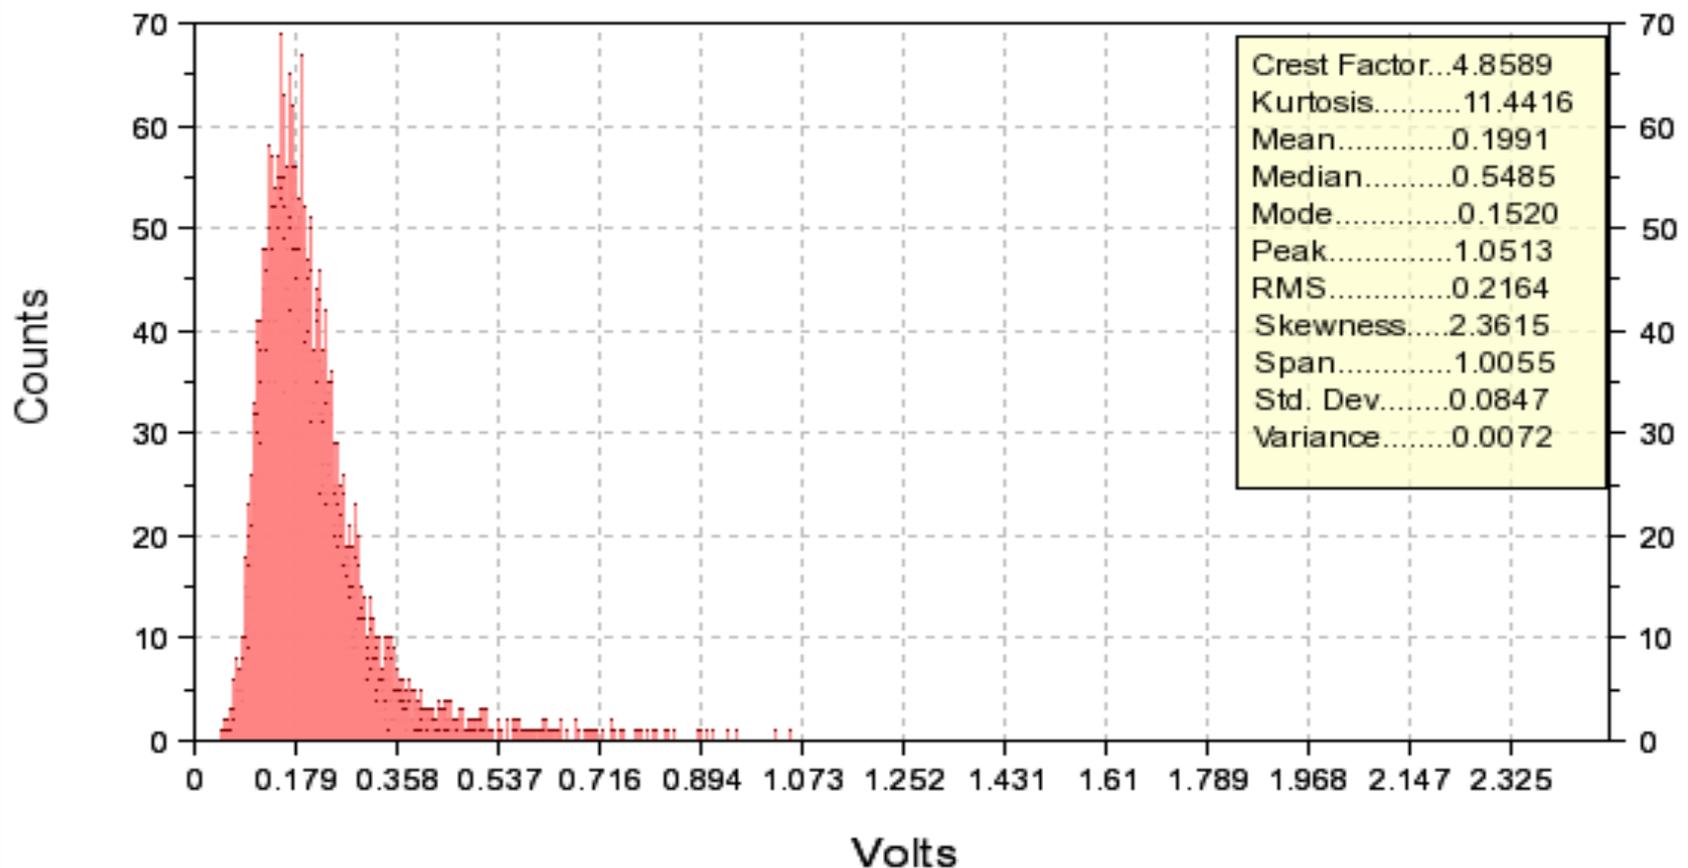
Histogram Plot - Normal

Date Recorded: 09/04/07 09:42:55

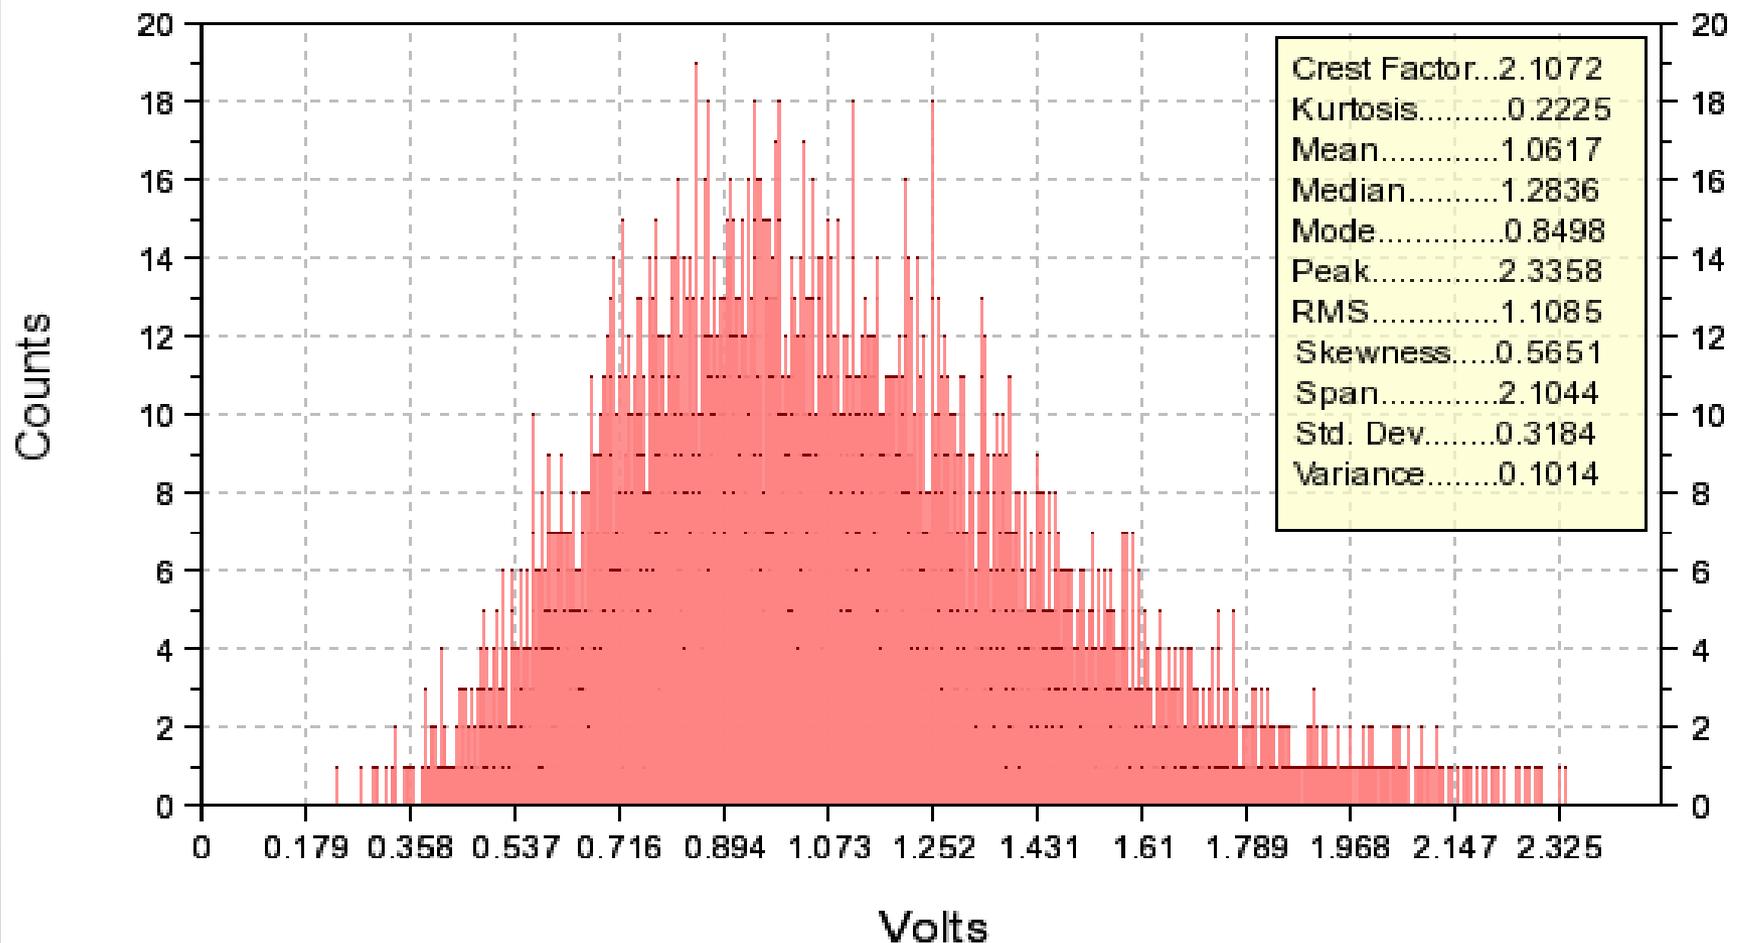
Histogram Plot - Abnormal

Date Recorded: 09/04/07 19:43:43

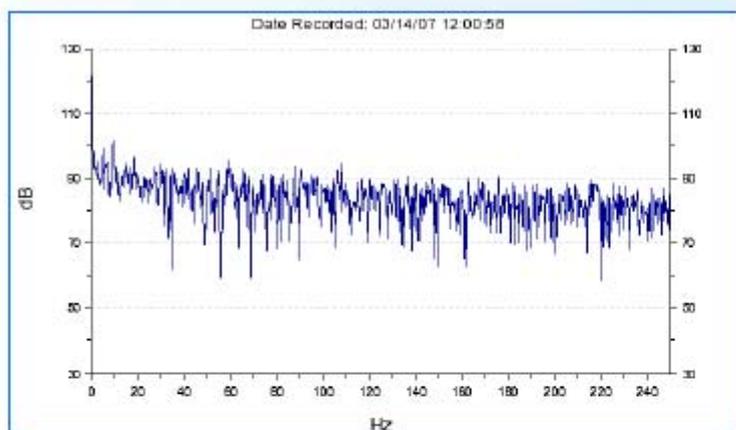
Generic FFT Spectral Analysis

Healthy

- Spectrum only contains friction and shock events
- Healthy components produce a flat spectrum
- Repetitive shock/friction events show up as significant spectral lines

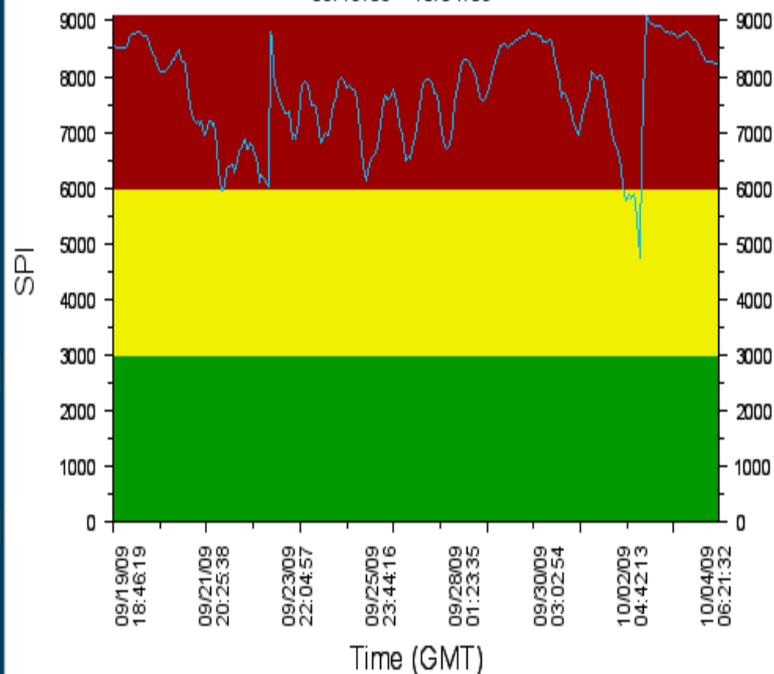
WTG - GBX HSS

09/19/09 - 10/04/09

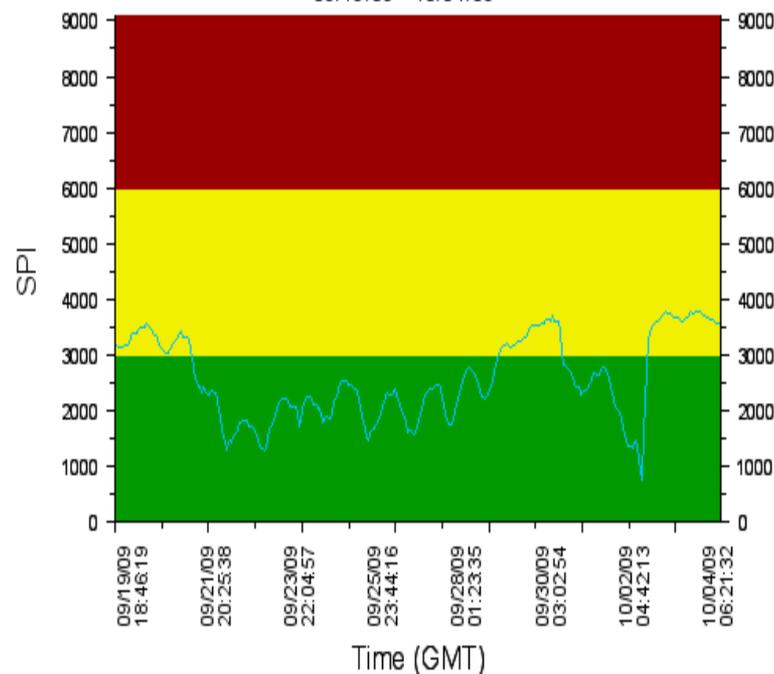
WTG - GBX HSS

09/19/09 - 10/04/09
