Effective Use of Large Wear Debris Particle Trends To Detect Key Failure Modes of Wind Turbine Gearboxes

Richard Dupuis, GasTOPS

**NREL Wind Turbine Condition Monitoring Workshop
Broomfield, Colorado, Oct 8-9, 2009**

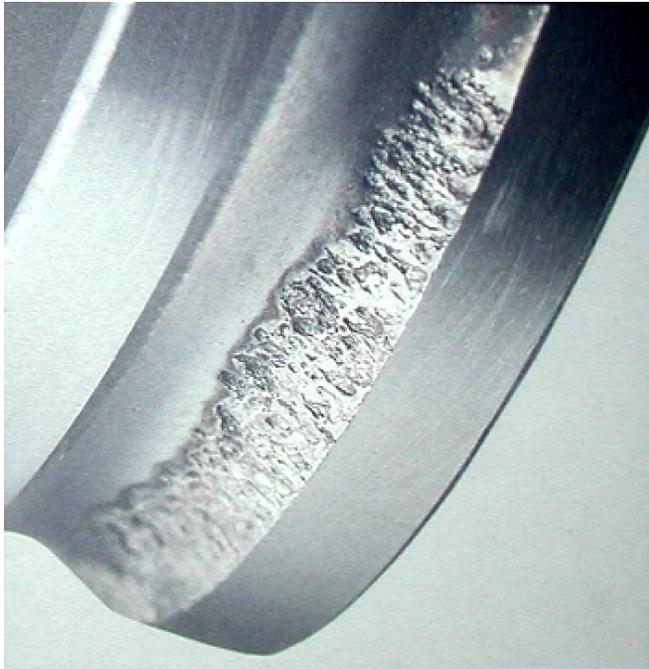
Bearing Spalling Damage

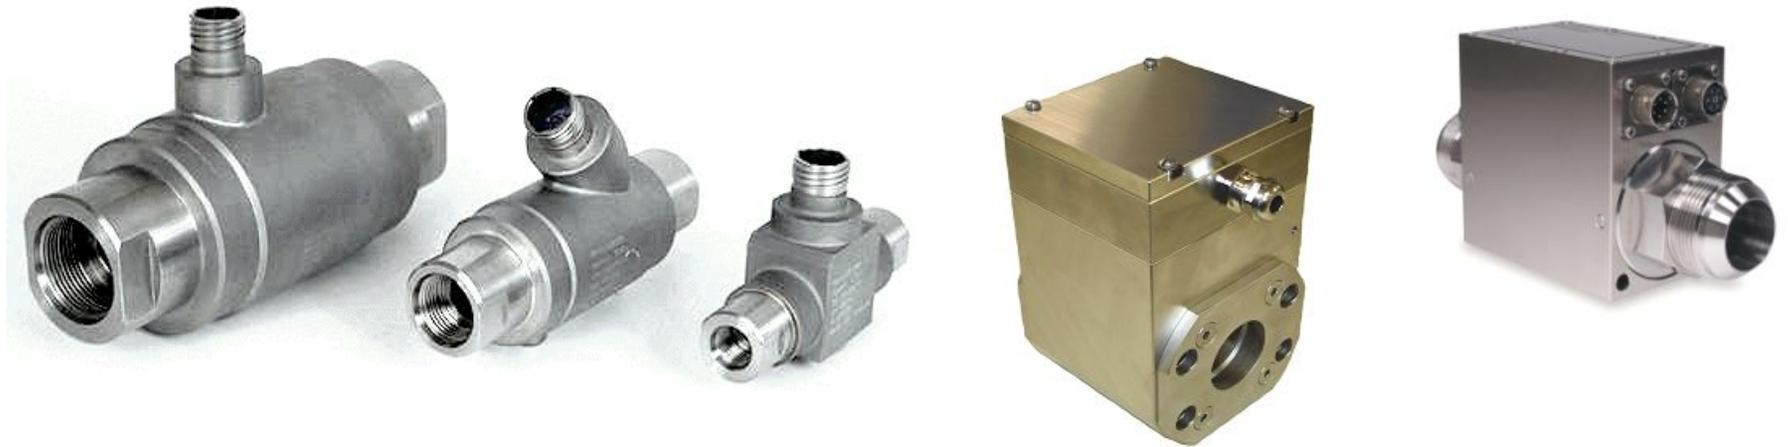
Oil Debris Monitor (ODM) Characteristics

- On-line, full-flow sensor fitted into lube oil system
- Based on inductive sensing technology
- Detects 100% of particles above minimum particle size threshold
- Detects both ferrous and non-ferrous metallic particles
- Quantifies metallic particle counts and rates

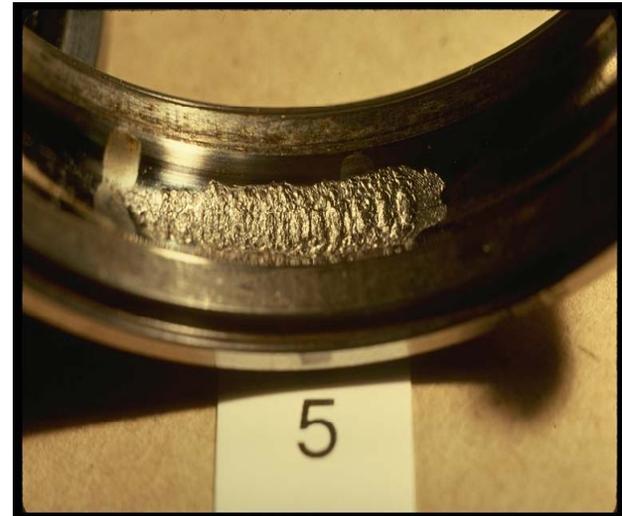
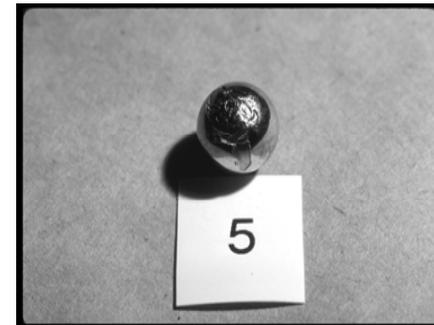
Small-Scale Bearing Damage

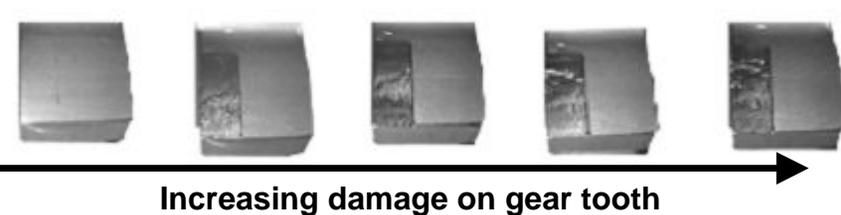
Ferrous Wear Debris Particle Trends

Figure 5.—Spur rig experiment after pitting damage was observed.

- Pattern of failure for surface fatigue of gears is similar to bearings

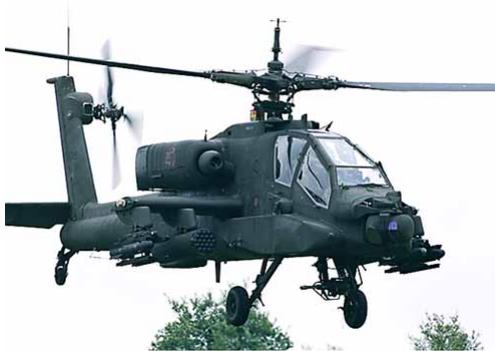
Ferrous Wear Debris Particle Trend

- Rig test of AH-64 drive-train at US Navy Patuxent River transmission test facility
- 200 hour high stress component qualification test
- No chip detector alarm
- Teardown confirmed damage limited to input shaft bearing of right nose gearbox

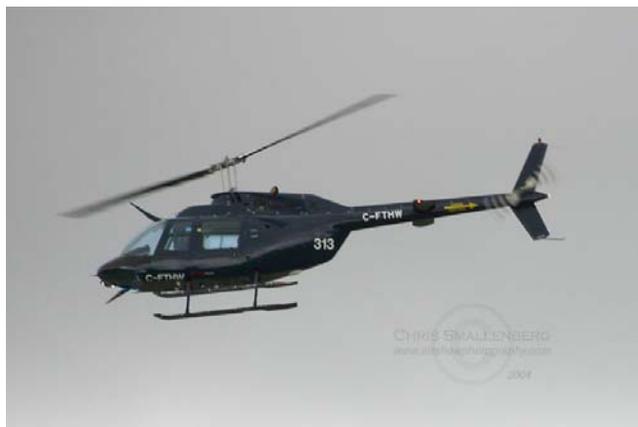
Cumulative Fe Count - Bell 206 Main Rotor Gearbox Overload Test

Fe Counts

- Rig test of a B206 main rotor gearbox at DSTO test facility
- 150% overload stress test

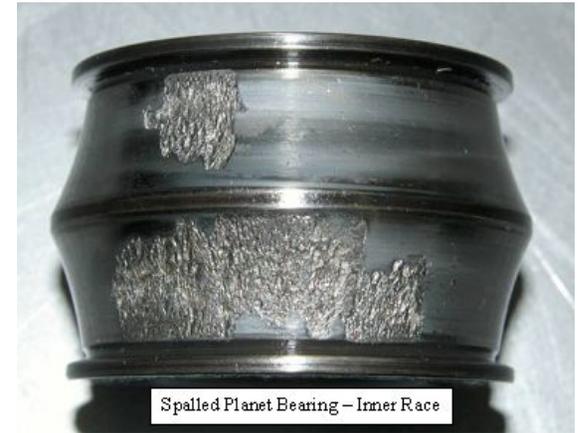
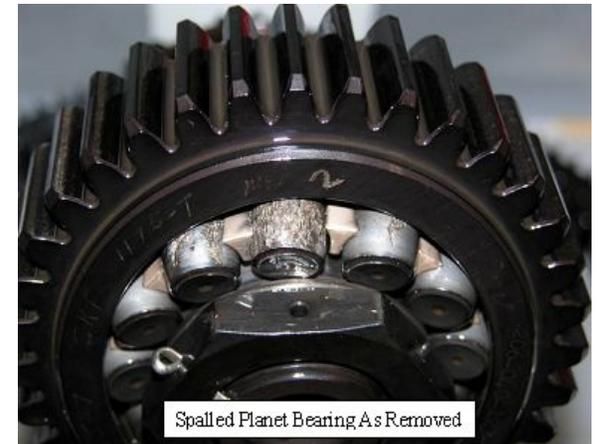
Main Transmission Planet Bearing Damage

- Test teardown showed damage limited to planet bearing

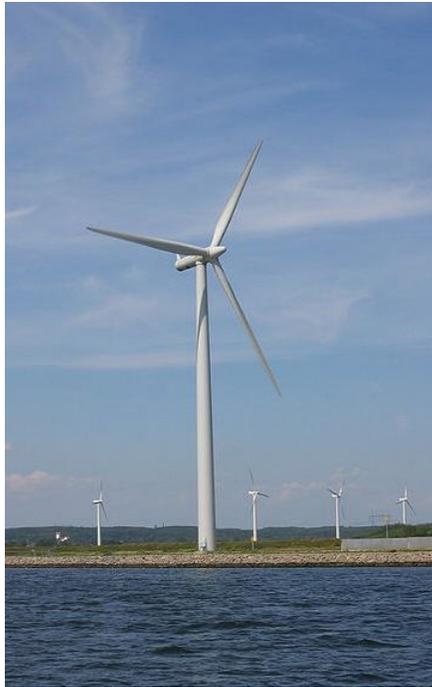
Ferrous Wear Debris Particle Trend

Wear debris particle sizes observed over 225 um

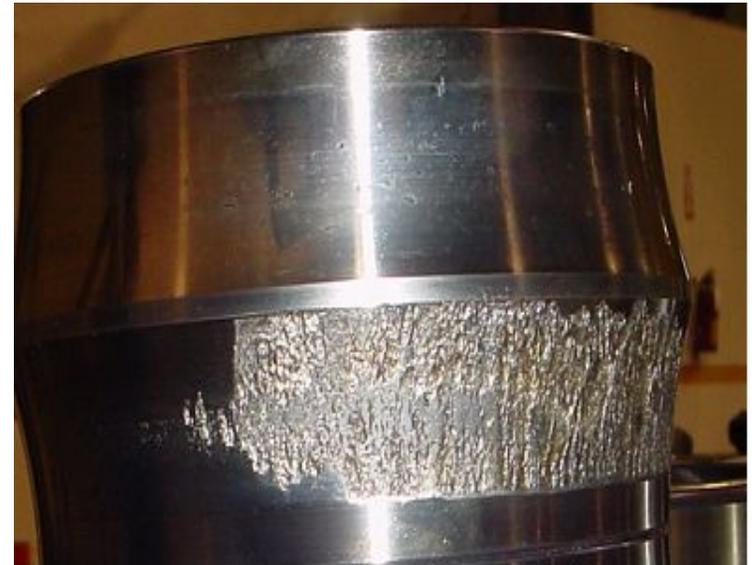
Planetary Stage Bearing Damage

Inner Race

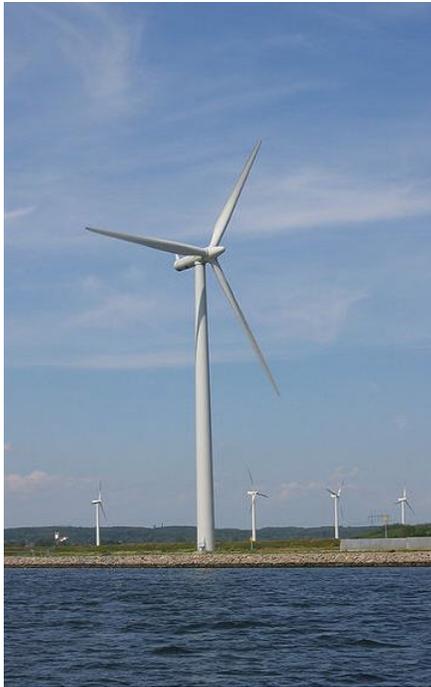
Ferrous Wear Debris Particle Trend

Wear debris particle sizes observed over 260 um

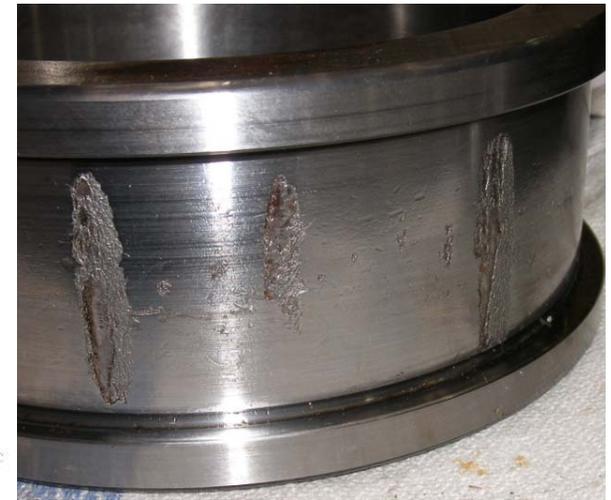
High Speed Stage Bearing Damage

Inner Race
